SELMON
EXPRESSWAY

South Selmon PD&E Study

**Cultural Resource
Assessment Survey
Report**

June 2021

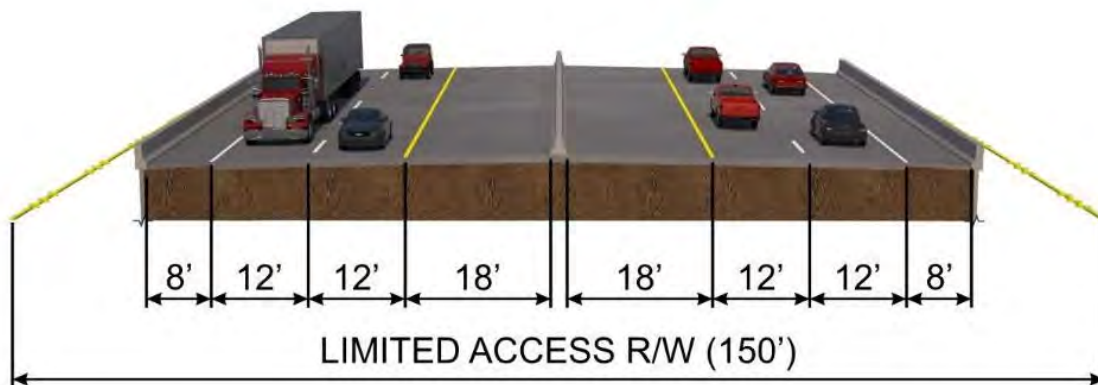
Figure 1.2. Existing Typical Section

The Selmon Expressway is a limited access, tolled facility providing east-west connectivity from Interstate 75 (I-75) to downtown Tampa and United States Highway 92 (US 92). Within the study limits, it currently consists of two 12-foot wide travel lanes in each direction separated by a 38-foot paved median with a concrete barrier wall. The outside shoulders are eight feet wide and contain either shoulder gutter with guardrail or shoulder gutter with barrier wall (see **Figure 1.2**). The facility is elevated through downtown Tampa and includes structures over the Hillsborough River and multiple roadway facilities.

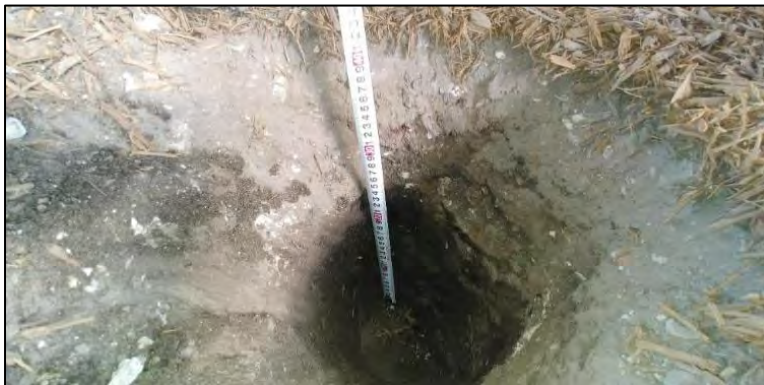
Figure 5.1. Shovel test, site, and historic resource location along the South Selmon PD&E Study APE.

Thirty shovel tests were excavated in the APE within the boundary of NRHP 8HI00013, all of which were negative (see **Figure 5.8**). All contained various amounts of fill and modern debris, but no 19th century deposits or aboriginal midden materials were uncovered. However, it is recommended that during construction for the project within the Fort Brooke site (8HI00013), ground disturbance that goes beyond the depth of one meter (3.3 ft) shall be monitored by a qualified archaeologist. Of the 30 shovel tests, nine were placed within or adjacent to 8HI00537 and three were within or adjacent to 8HI00996. Updated FMSF forms have been completed with this negative data. FMSF forms are contained in **Appendix A**.

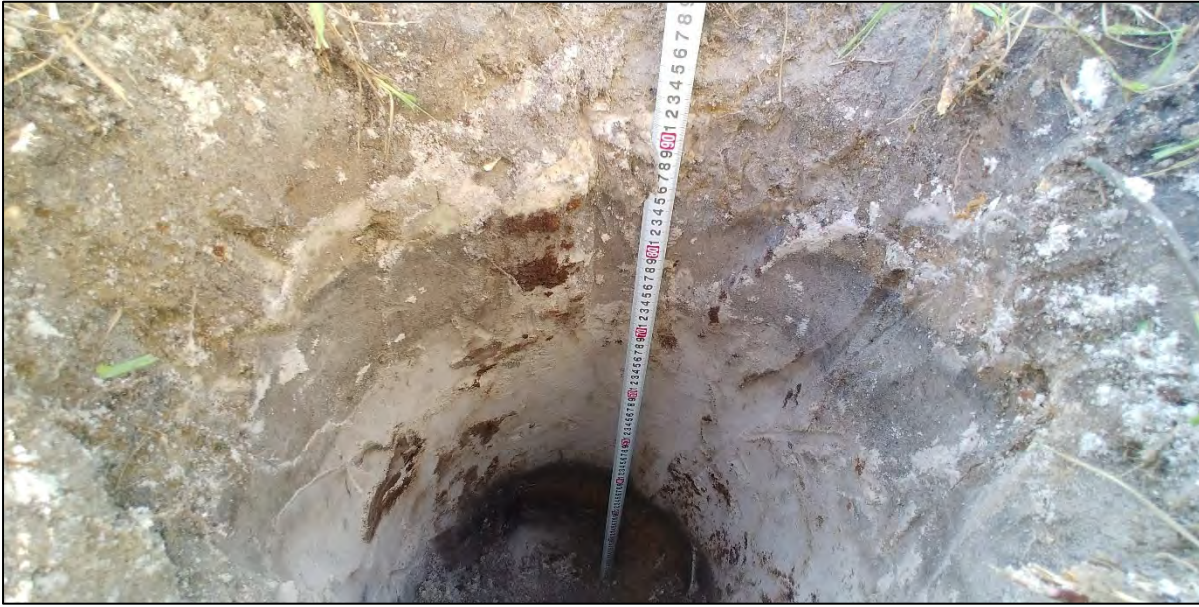
Photo 5.2. Less disturbed stratigraphy within the historic district.

The shovel tests indicated a uniformity in profiles throughout most of the APE with over 1 meter (3.3 ft) of mixed sand and fill material. The average profile of urban lands consisted of 100 cm (40 in) dark grey brown mottled sand with varying amounts of concrete, glass, asphalt, brick, plastic, and gravel. At times, soil was impenetrable (**Photo 5.1**). The soil was only slightly different in profile moving west along the corridor near the Palma Ceia and Hyde Park Historic Districts. There, the first 40 cm (16 in) was fill and was followed by a 60 cm (24 in) of light brown sand or pale brown grey sand (**Photo 5.2**). The urban soils near the western terminus had a different profile as well. The upper 30 cm (12 in) was dark grey sand, underlain by 40 cm (16 in) of light grey sand, and then 30 cm (12 in) of reddish-brown sand (see **Photo 5.3**). The stratigraphy of the shovel tests is provided in **Appendix C**.

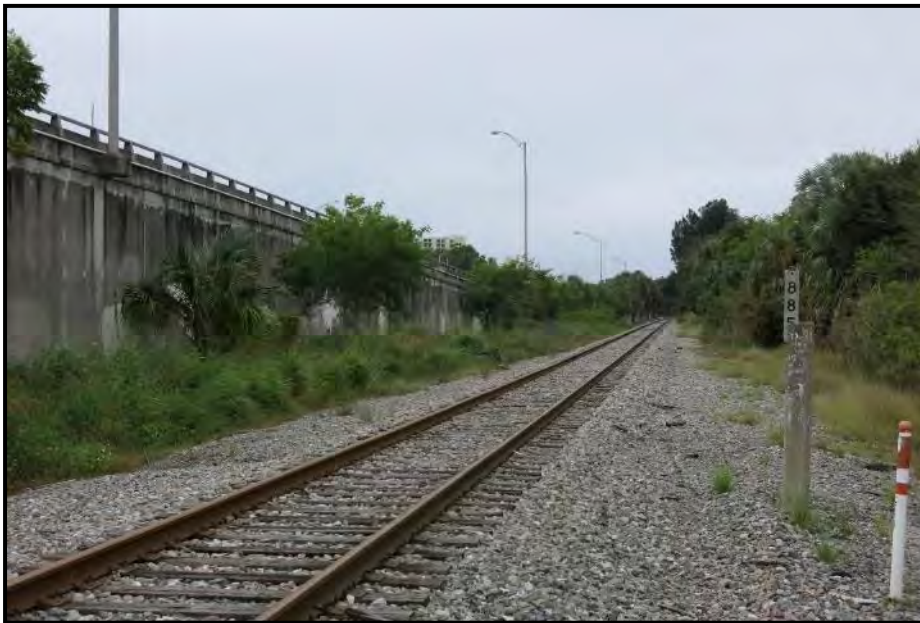
8HI11519: The segment of Seaboard Coast Line/CSX Railroad within the APE is approximately 3.3-miles long and is located in Sections 3 and 4 of Township 30 South, Range 18 East; Sections 23, 26 – 27, and 34 of Township 29 South, Range 18E; and Section 19 of Township 29 South, Range 19 East (USGS Gandy Bridge 1956; USGS Tampa 1956) (**Photo 5.5**). The rail line consists of two standard gauge tracks affixed to timber railroad ties with double shoulder tie plates and hook head track spikes laid over gravel track ballast. The resource has been updated to modern standards, no longer reflecting ca. 1890 materials, and railroad crossings located within the APE are currently undergoing replacement.

While the railbed is a typical example found throughout Florida, it meets the requirements found in the Florida's Historic Railroad Resources Multiple Property Listing under property type F.3, Railroad Structures, within the APE. The railroad possesses significance for its association and engineering trends with the development of Florida's railroads and served as a transportation function. Furthermore, the railroad was constructed in the late Nineteenth Century, which is considered one of the significant periods of railroad history as stated in the *Florida's Historic Railroad Resources Multiple Property Listing* (Johnston & Mattick 2001). Therefore, the Seaboard Coast Line/CSX Railroad (8HI11519) within the APE appears eligible at the local level for listing in the NRHP under Criteria A and C in the areas of Transportation and Engineering. In addition, the railroad is a contributing resource to the existing Florida's Historic Railroad Resources Multiple Property Listing under property type F.3.

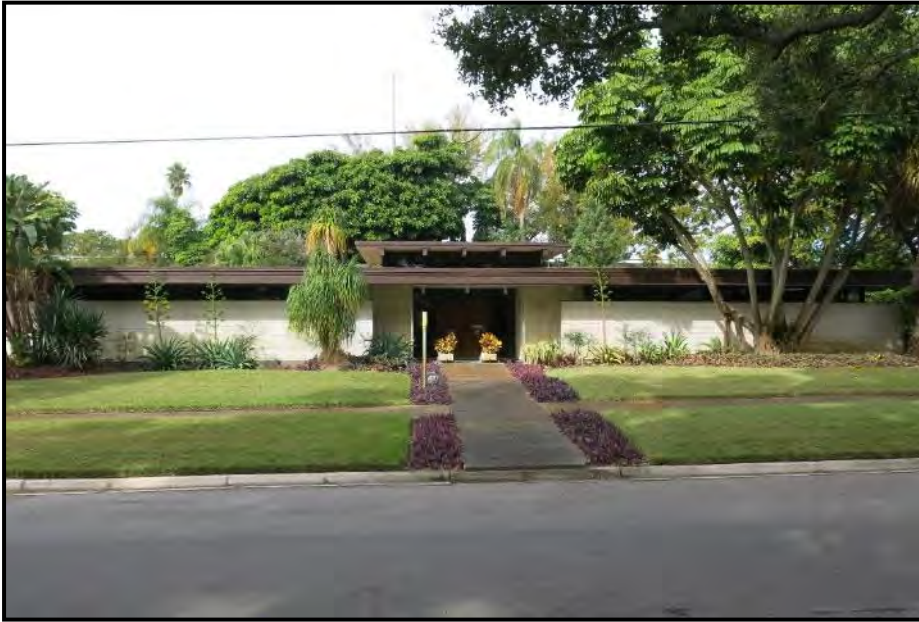
8HI14745: The Mid-Century Modern style building at 3501 S Drexel Avenue was constructed in ca. 1962 (**Photo 5.6**). The one-story, irregular plan building rests on a concrete slab foundation and has a pre-cast concrete brick structural system clad in stack bond pre-cast concrete brick, vertical redwood siding, stressed skin plywood panels, and stucco. The flat roof and flat clerestory cupola are covered with built-up roofing membrane. The main entryway is recessed on the east elevation through double redwood doors with center doorknobs, a mail slot, and a continuous glass sidelight and transom light surround beneath the principal roof. Visible windows include ribbon grouped, one-light metal clerestory units. Distinguishing architectural features include a low, broad horizontal plan, wide overhanging boxed eaves with wide fascia boards, exposed beams beneath the cupola roofline, a stack bond pre-cast concrete brick three-quarter height wall, and a metal louvre screen wall. A two-car attached carport with a metal louver screen wall is located on the south end of the east elevation. A cylindrical metal lamppost and square concrete planters are located to the east of the dwelling. Alterations include replacement roofing and a flat roof addition is present on the west elevation.

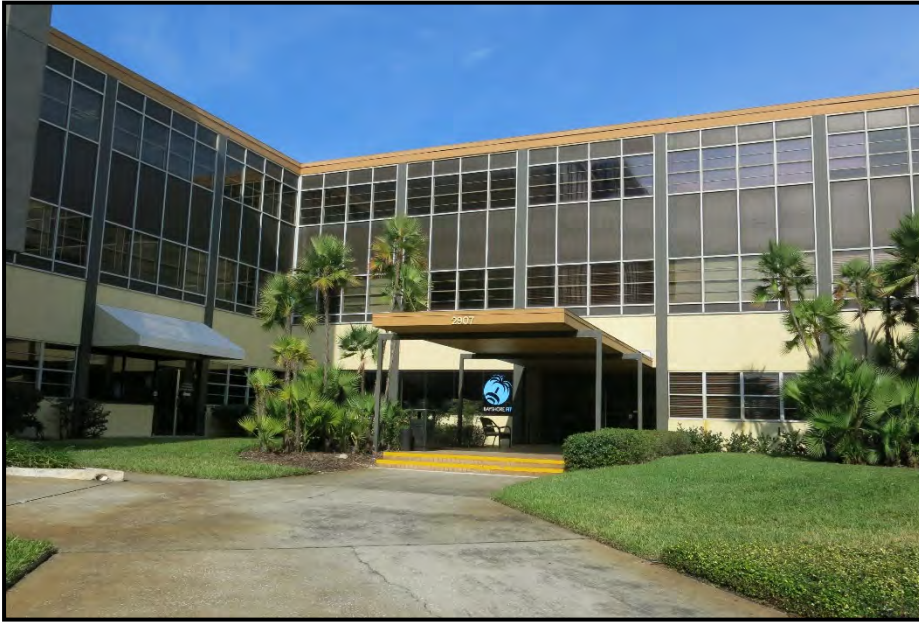
Photo 5.8. 2907 W Bay to Bay Blvd/Boulevard Building (8HI14774), looking north.

8HI14774: The Mid-Century Modern style building at 2907 W Bay to Bay Boulevard was constructed in ca. 1963 (**Photos 5.8 & 5.9**). The three-story, irregular plan building rests on a concrete slab foundation and has reinforced, pre-cast concrete structural system clad in stucco, brick, and concrete block. The flat roof is covered with built up roofing. The main entryway is on the south elevation through double doors located beneath a flat canopy with metal supports. Visible windows include a mixture of paired and grouped, two-over-two metal single-hung sash units. Distinguishing architectural features include an entrance defining flat canopy, enamel panels surrounding the windows with aluminum trim, stucco

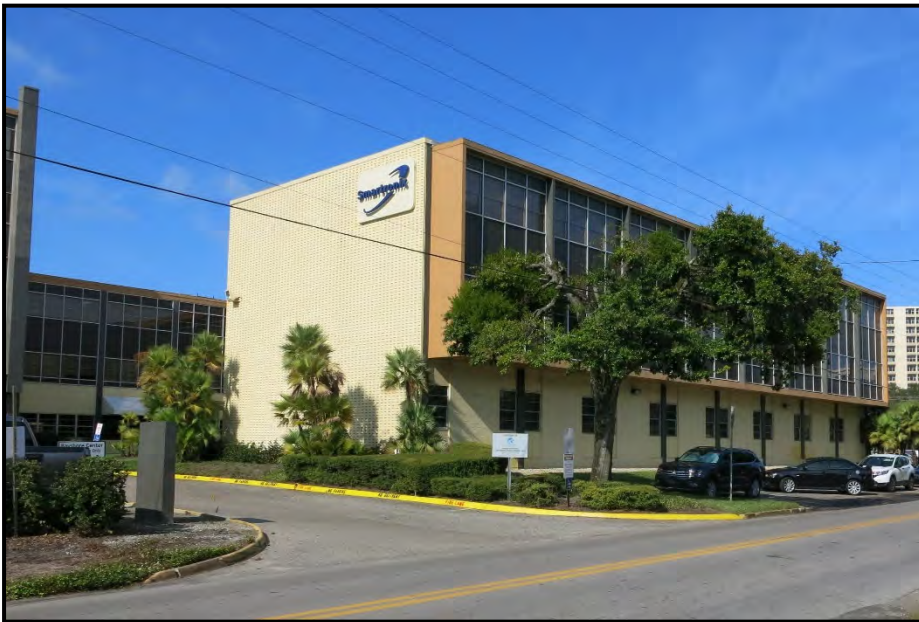
pilasters, brick paneling, concrete block siding decoratively placed with the cells facing the exterior, a central courtyard formed by the irregular but generally U-shaped building, and a cantilevered east elevation. Alterations include replacement roofing. The NRHP eligible ca. 1961 Bayshore Center (8HI11583) is located south of the building. In addition, the Boulevard Building – and adjacent Bayshore Center (8HI11583) also constructed by the Austin Construction Company – marked the beginning of the suburban general office building in Tampa, in contrast to downtown office developments (Knight 1961). Overall, the building is good example of a Mid-Century Modern style office building. The building is a highly intact resource that retains many of its original materials and architectural elements that are common features to the 1960s. As a result, 8HI14774 appears individually eligible for listing in the NRHP under Criteria A and C in the areas of Community Planning & Development and Architecture.

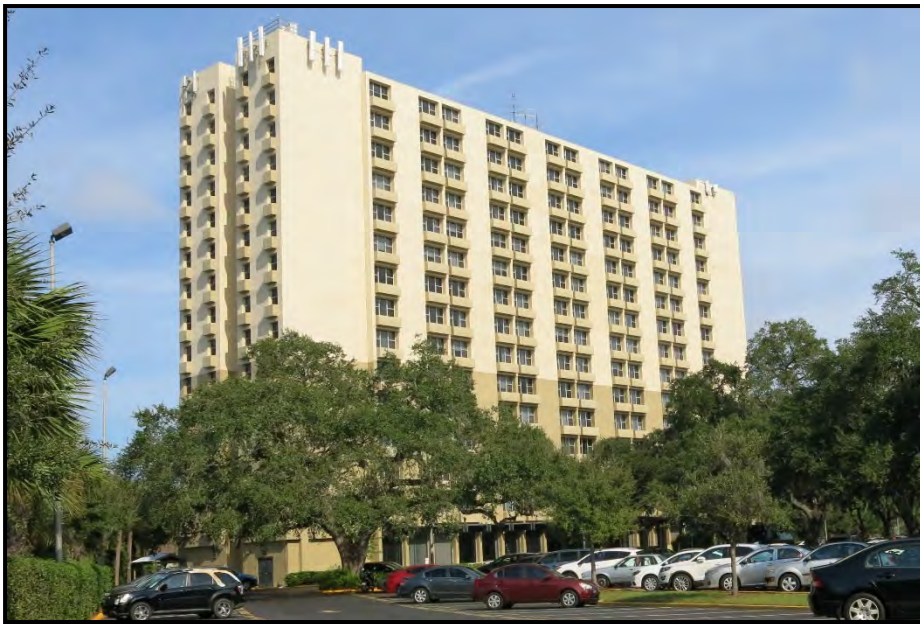
8HI14777: The Mid-Century Modern style building at 2909 W Barcelona Street was constructed in ca. 1967 (**Photo 5.10**). This 15-story, irregular plan rests on a concrete slab foundation and has a metal skeleton structural system clad in stucco. The flat roof is sheathed in built up roofing membrane and lined by stucco parapets. The main entryway is on the south elevation through double metal frame full view doors with sidelights and a transom light, as well as a metal frame full view automatic sliding door unit. The main entryway is located beneath a flat roof canopy that extends outward from the south elevation and doubles as a porte-cochere for resident drop-offs. Visible windows include a mixture of individual, metal picture units comprised of a central fixed pane flanked by one-over-one single-hung sash units; and individual, single pane metal fixed units. Distinguishing architectural features include a three-part plan including the central mass flanked by two rectangular projections on both the east and west elevations, stucco parapet walls, stucco incised with a rectangular pattern, squared stucco window awnings, stucco pilasters, and non-functioning stucco balconies for each unit. Alterations appear to be limited to routine maintenance such as replacement roofing.

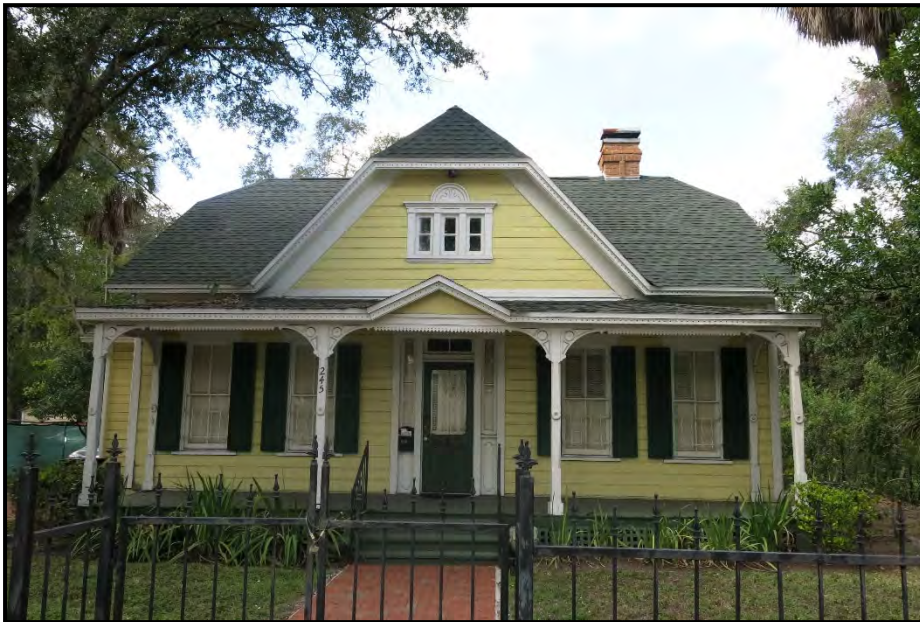
8HI10007: The Folk Victorian style building at 245 S Hyde Park Avenue was constructed in ca. 1889 (**Photo 5.11**). The one-story, irregular plan building rests on a brick pier foundation and has a wood frame structural system clad in clapboard and novelty siding. The jerkinhead roof is covered with composition

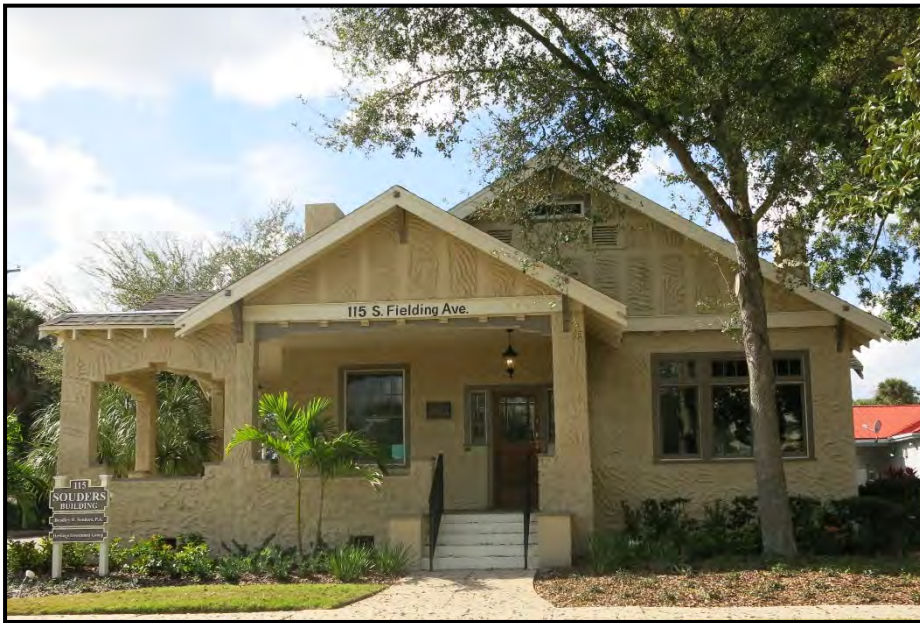
8HI01661: The Craftsman style building at 115 S Fielding Avenue was constructed in ca. 1914 (**Photo 5.12**). The two-story, irregular plan building rests on a continuous foundation obscured by stucco and has a wood frame structural system clad in heavily textured stucco. The cross-gabled roof and hip roof extension are covered with composition shingles. A stepped masonry chimney clad in textured stucco is located on the gable end of the north elevation and an additional masonry chimney clad in textured stucco is located within the ridge of the south elevation. The main entryway is on the east elevation through a single wooden Dutch door with paneling, a six-pane inset light, and six pane side lights within a partial width open porch beneath a gable roof with stucco porch supports and half wall, decorative arches, and a flat roof extension. Visible windows include a mixture of individual and grouped (3, 4, bay), six-over-one, eight-over-one, and ten-over-one wooden double-hung sash units; paired and grouped (3) single pane wooden fixed units with three-light and four-light transoms; and paired four-light wooden casement units. Distinguishing architectural features include overhanging eaves with exposed rafter tails, heavily textured stucco with decorative half-timbering, belly band trim with modillions, wooden brackets, decorative porch openings, rectangular foundation vents, and rectangular gable vents. Alterations include replacement roofing.

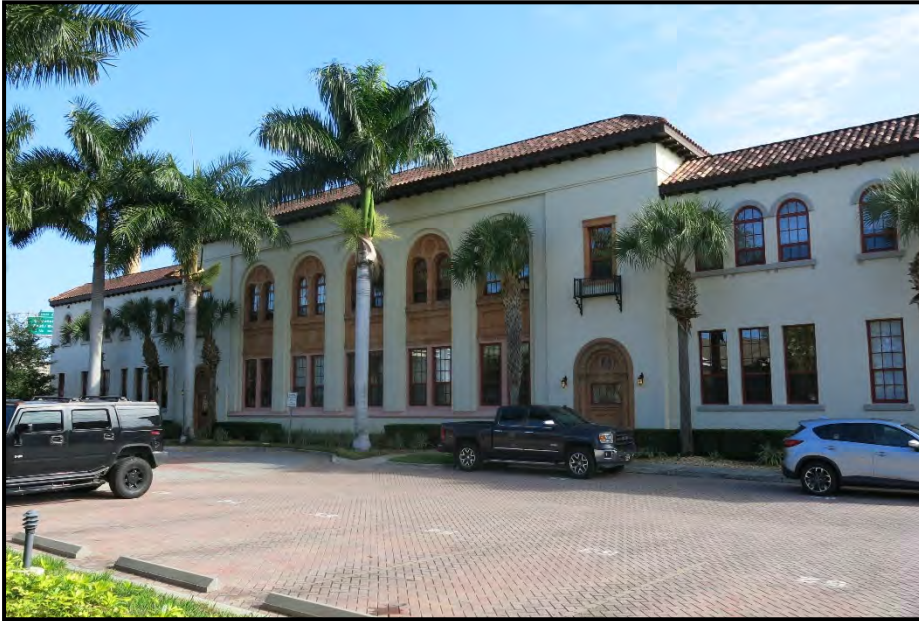
8HI01759: The Mediterranean Revival style building located at 1501 W Horatio Street (formerly 420 S Dakota Avenue) in Tampa, Florida was constructed in ca. 1926 (**Photo 5.13**). The Seybold Bakery factory was constructed by the Seybold Baking Company, the owners and bakers of the Southern Breads and Southern Cakes brands (Photo 1). Producing the same brands, the Columbia Baking Company took over the operation during the mid-1940s followed by Southern Bakeries Company during the mid-1950s. In 1971, ITT Continental Baking Company began operation, and the factory was utilized to produce Wonder Bread products until 2003 (B.C. Manion 2003, City of Tampa 2018). The transition into a residential development began in 2004 and the building received local historic designation in 2005 (Poltilove 2004, City of Tampa 2018). The Seybold Bakery is listed as a contributing resource to the National Register of Historic Places (NRHP)-listed Hyde Park Historic District (FMSF 8HI01050).

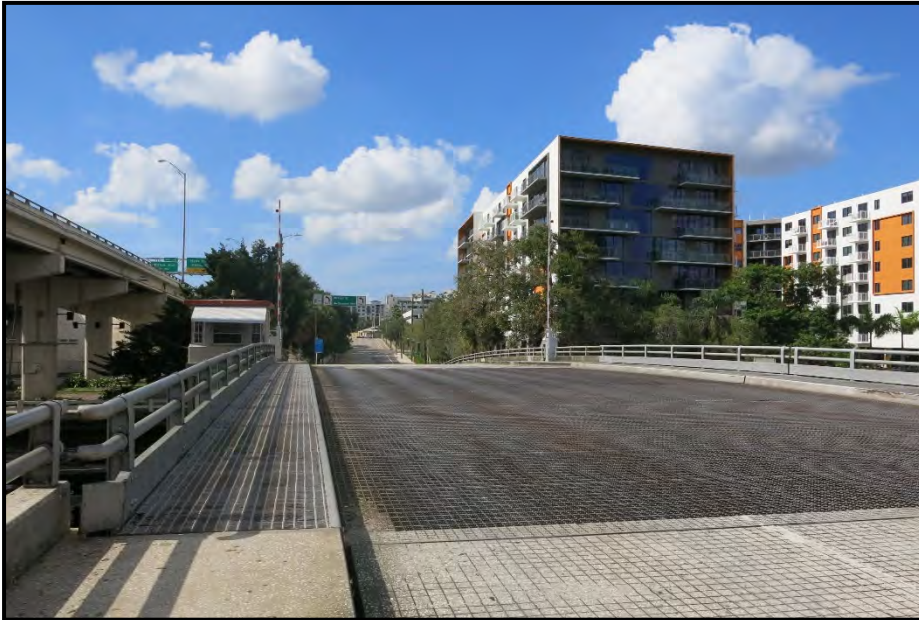
Photo 5.16. Brorein Bridge; FDOT Bridge No. 105501 (8HI11540), looking northwest.

8HI11540: The Brorein Street Bridge (FDOT No. 105501) was determined eligible for listing in the NRHP by the SHPO in 2014 as part of the Update of Florida Historic Highway Bridges (**Photo 5.16**). The bridge is a 1959 movable bascule bridge that crosses the Hillsborough River and is significant under NRHP Criterion A in the areas of Community Planning and Development and Transportation and Criterion C in the area of Engineering. The Brorein Street Bridge has lost some of its original design elements; however, it continues to remain a good example of a mid-century movable bascule bridge that was constructed through a unique source of funding (FDOT 2012). The bridge was funded by the Public Improvement Program for the City of Tampa with the purpose of alleviating downtown congestion by providing an additional four lane, two-directional road between Downtown Tampa and the area to the west of the Hillsborough River.

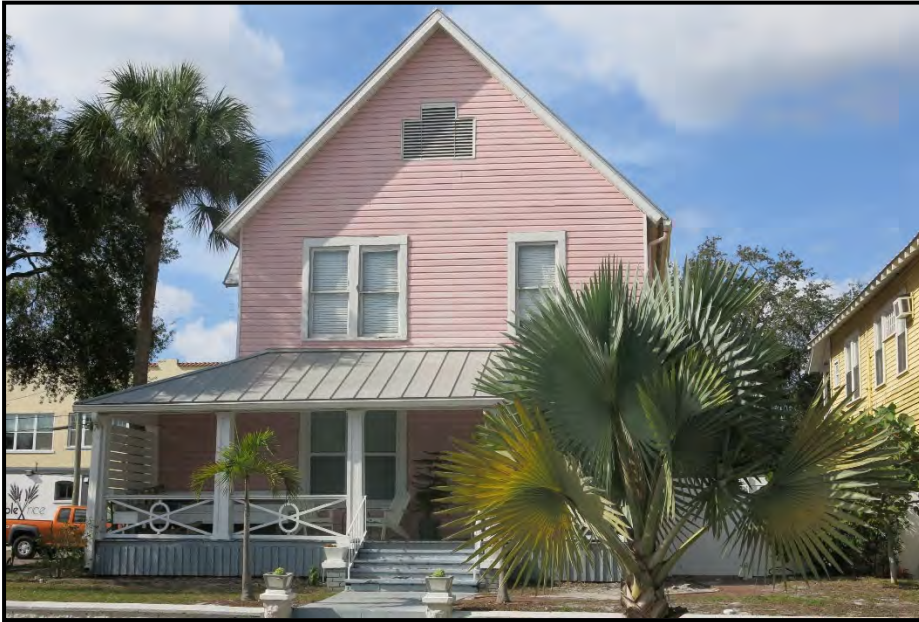
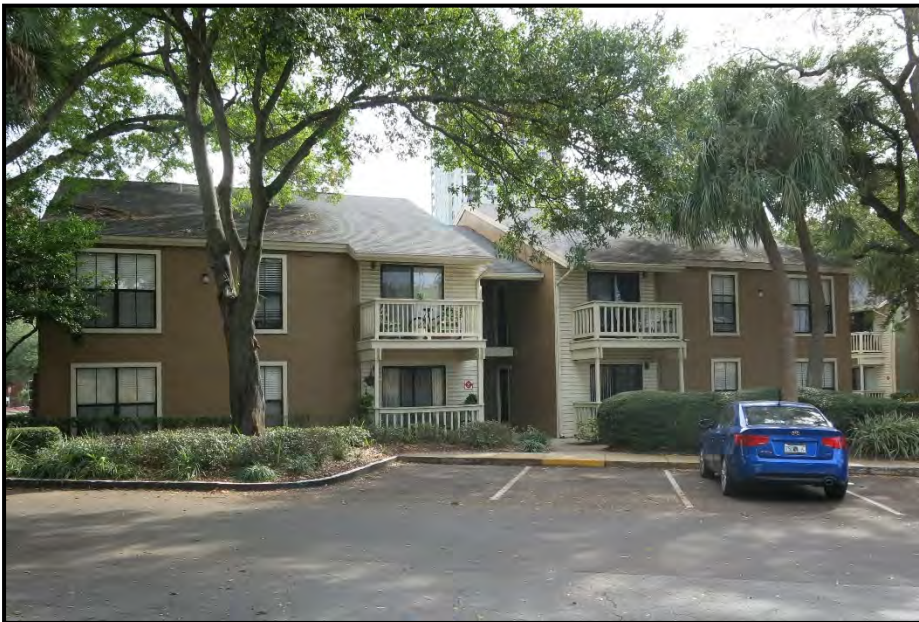
Frame Vernacular: A total of 38 historic resources within the APE are of the Frame Vernacular style (**Photos 5.17 and 5.18**) and have construction dates that range from 1902 to 1974 (see **Table 5.3**). The majority of these resources are residential with a few commercial buildings represented in this style. Frame Vernacular style buildings are simple structures built with available local materials and boasting little ornamentation (McAlester 2013). They are often built by developers, contractors, master carpenters, or the building's occupants. These buildings are decidedly practical structures. Within the APE, this building type has pier, continuous, or slab foundations. Gable roofs are most common, and the majority

of the roofs are clad with composition shingles. The majority of these buildings are clad in wood siding, vinyl, or stucco. Fenestration typically includes single-hung sash windows, but awning and fixed windows are also present. Exterior ornamentation is minimal, and typically consists of wood window and door surrounds, corner boards, gable vents, and exposed rafter tails. The majority display alterations or additions, such as replacement siding and windows and living-space additions.

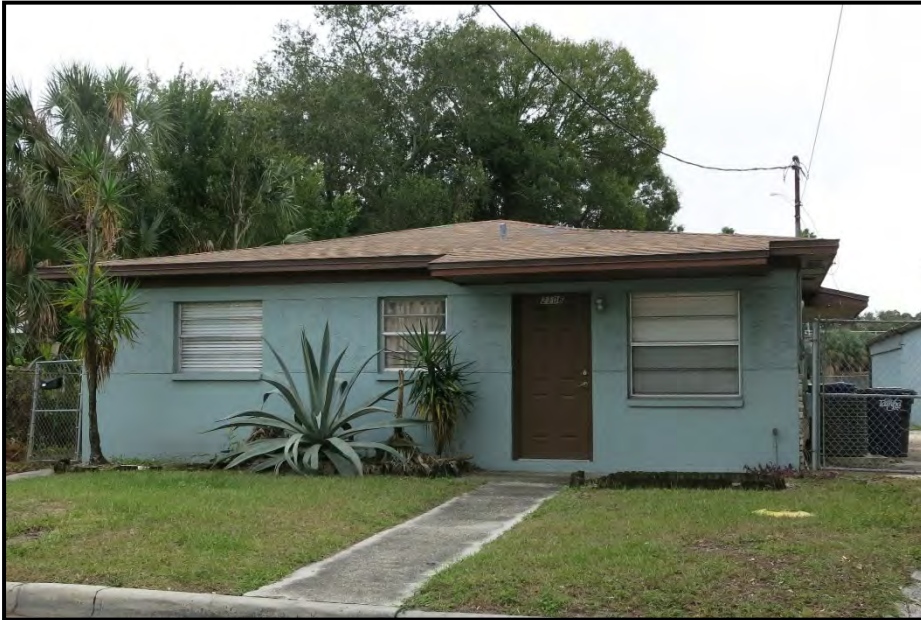
Photo 5.20. 2907 W Bay to Bay Blvd/Boulevard Building (8H114740), looking southeast.

Masonry Vernacular: A total of 32 historic resources within the APE are of the Masonry Vernacular style (**Photos 5.19 and 5.20**). The majority of these resources are a mix of residential and commercial buildings with construction dates that range from 1928 to 1973 (see **Table 5.3**). Similar to Frame Vernacular style buildings, Masonry Vernacular style buildings reflect the local customs, environment, and building materials, and do not rely on academic architectural vocabulary for their design and ornament. Within the APE, this building type generally has concrete slab foundations and concrete block walls. Roof types commonly consist of gable and hip, most of which are clad with composition shingles. The exterior cladding often consists of painted concrete block, stucco, and artificial masonry or brick veneer. Windows typically are awning or single-hung sash. Most display replacement windows and roofs, fenestration changes and additions are common.

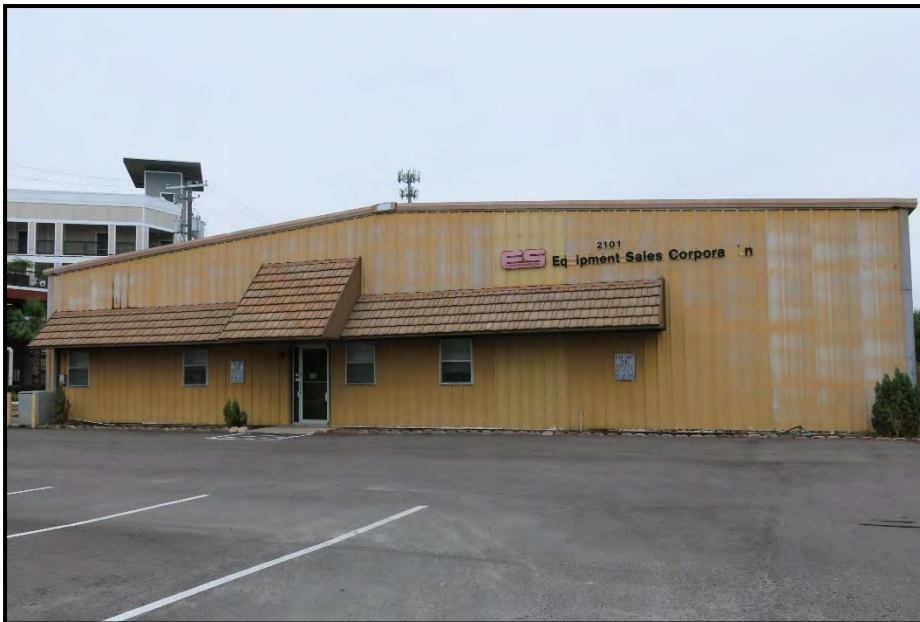
Industrial Vernacular: Three historic resources within the APE are of the Industrial Vernacular style (8HI14800; 8HI14826; 8HI14827) (**Photo 5.21**) and have construction dates of 1946 and 1973 (see **Table 5.3**). Similar to Masonry Vernacular and Frame Vernacular style buildings, Industrial Vernacular style structures are simply built with available local materials and display little ornamentation. Within the APE, this building type usually has a slab foundation, and gable or flat roofs are the most represented roof types. The building exteriors, as well as the roofs, are clad with metal or masonry. The three buildings display fenestration alterations as well as new roofing and siding.

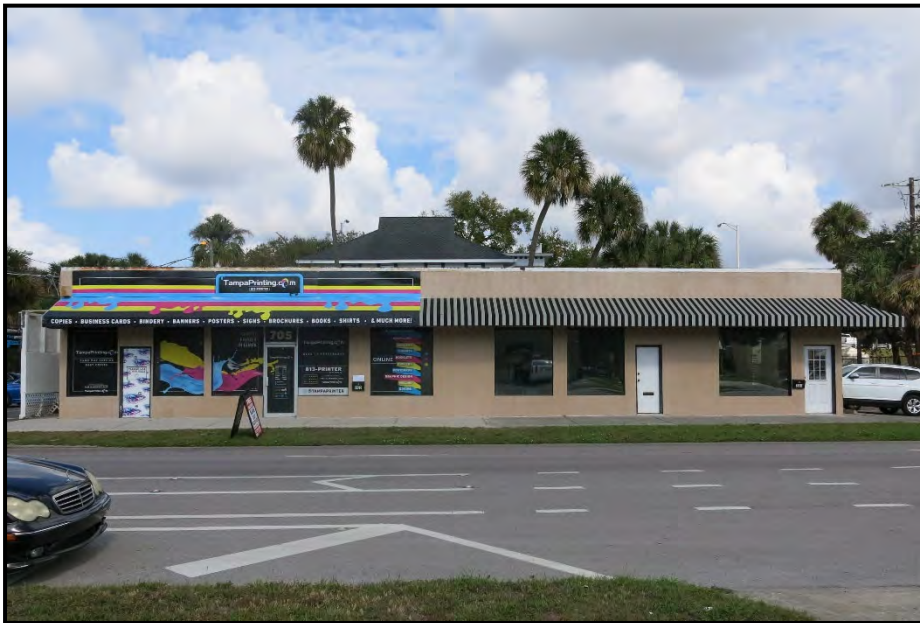
Commercial: Five historic resources within the APE are of the Commercial style (8HI14765, 8HI14766, 8HI14820, 8HI14821, 8HI14825) (**Photo 5.22**), and have construction dates between 1946 to 1958 (see **Table 5.3**). Within the APE, this building type usually consists of multiple units beneath a flat roof and parapet. Most entrances are through metal doors with full-view glass panels, fronted by a full-width open, entryway. Most of the building exteriors are clad with stucco. Full-length, fixed pane windows with metal frames are most common, and exterior ornamentation is minimal. The majority display fenestration alterations as well as new roofing and siding.

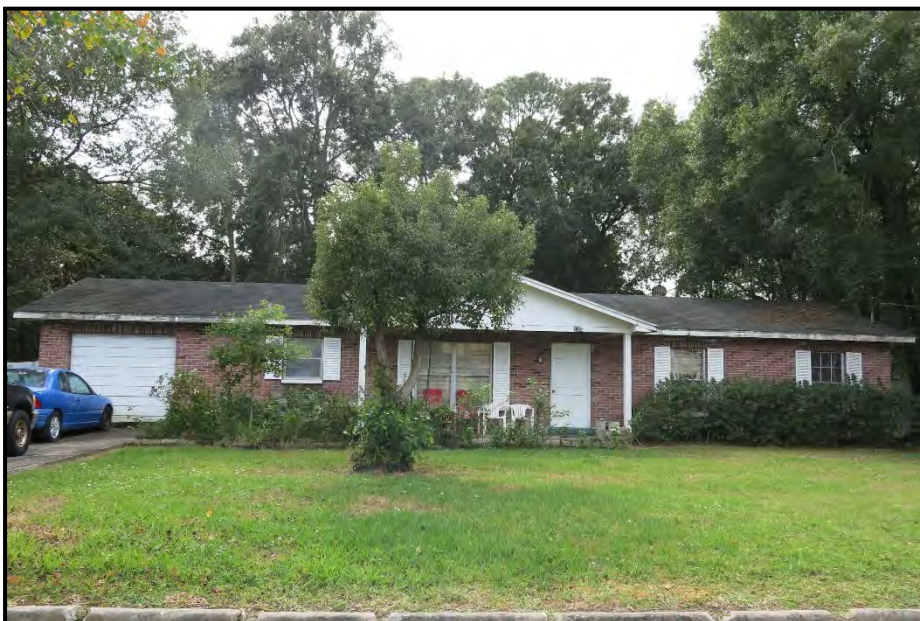
Photo 5.23. 3306 W Sevilla St (8HI14752), looking south.

Ranch: Fourteen historic resources within the APE are of the Ranch style (8HI14728, 8HI14729, 8HI14743, 8HI14747, 8HI14748, 8HI14752, 8HI14754, 8HI14759, 8HI14795) (**Photos 5.23**), five of which are considered Minimal Ranch style (8HI14725, 8HI14726, 8HI14727, 8HI14750, 8HI14761) (**Photo 5.24**). These buildings have construction dates between 1947 to 1973 (see **Table 5.3**) and the majority are residential buildings. The style, which gained popularity after World War II, features low-slung buildings and a low-pitched roof with large windows (McAlester 2013). Within the APE, this building type has continuous and slab foundations. Hip and gable roofs are most common, and the majority of the roofs are clad with composition shingles. The majority of these buildings are clad in stucco and brick. Fenestration typically includes awning and single-hung sash windows. Exterior ornamentation is minimal, and typically consists of gable vents and wide roof overhangs. Most display alterations or additions, such as replacement roofs and windows and living-space additions.

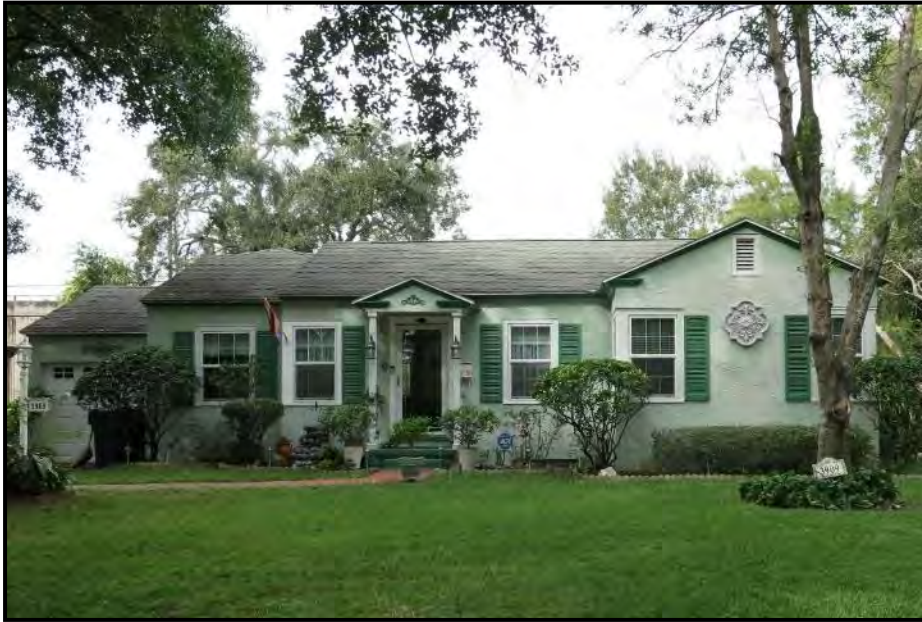
Photo 5.25. 3909 S Drexel Ave (8HI14731), looking northwest.

Minimal Traditional: Ten historic resources within the APE are of the Minimal Traditional style (8HI14731 through 8HI14734; 8HI14737, 8HI14739, 8HI14753, 8HI14755, 8HI14756, 8HI07214) (**Photo 5.25**) and have construction dates between 1924 and 1947 (see **Table 5.3**). The style is limited to residential buildings within the APE. The style, which gained popularity during the Great Depression through to post-World War II, features generally one-story buildings and a low- to intermediate-pitched roof with double- or single-hung sash windows (McAlester 2013). Within the APE, this building type has continuous or slab foundations. Gable roofs with minimal eave overhang are most common, and the majority of the roofs are clad with composition shingles. The majority of these buildings are clad in stucco, brick, and vinyl. Fenestration typically includes single-hung sash windows. Exterior ornamentation is minimal, and typically consists of gable vents and shutters. Most display alterations or additions, such as replacement roofs and windows and living-space additions.

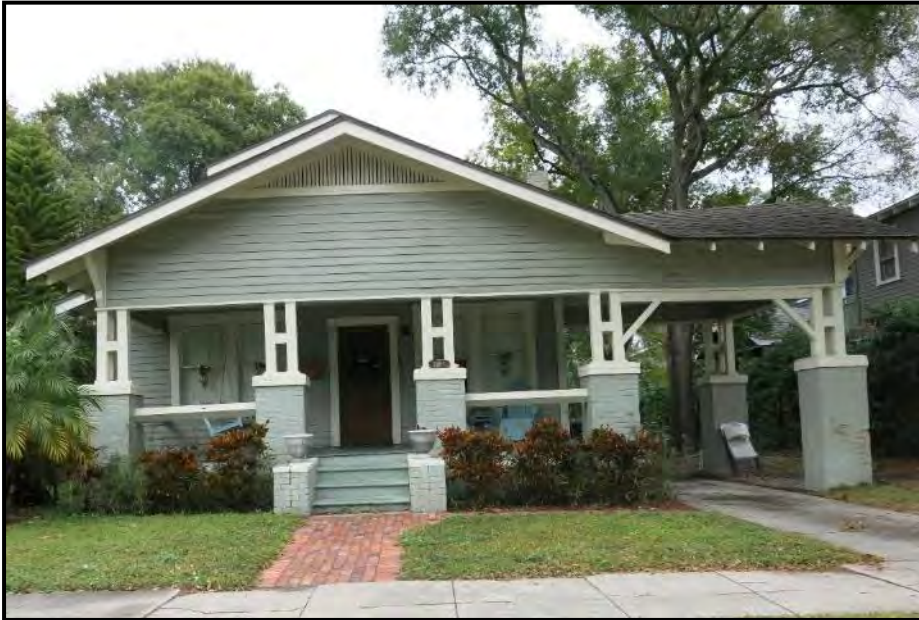
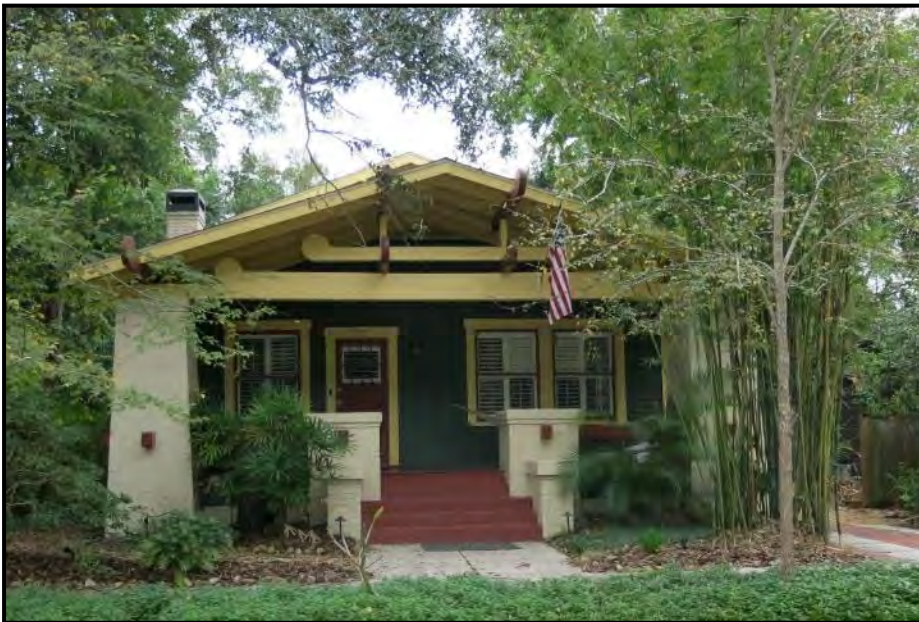
Craftsman: Thirty historic resources within the APE are of the Craftsman style (**Photos 5.26 and 5.27**) and have construction dates that range from the 1920s through the 1930s (see **Table 5.3**). The style is limited to residential buildings within the APE. The Craftsman style gained popularity in the first three decades of the 20th century and was inspired by both the English Arts and Craft Movement and Asian architecture (McAlester 2013). It features low pitched roofs, prominent porches, and wood ornamentation. Within the APE, this building type has pier and continuous foundations. Gable roofs are most common,

and the majority of the roofs are clad with composition shingles. The majority of these buildings are clad in wood siding. Fenestration typically includes wood single-hung sash windows. Exterior ornamentation features exposed rafter tails, wood braces, and porch supports and columns. The majority display alterations or additions, such as replacement roofs and windows, enclosed porches, and living-space additions.

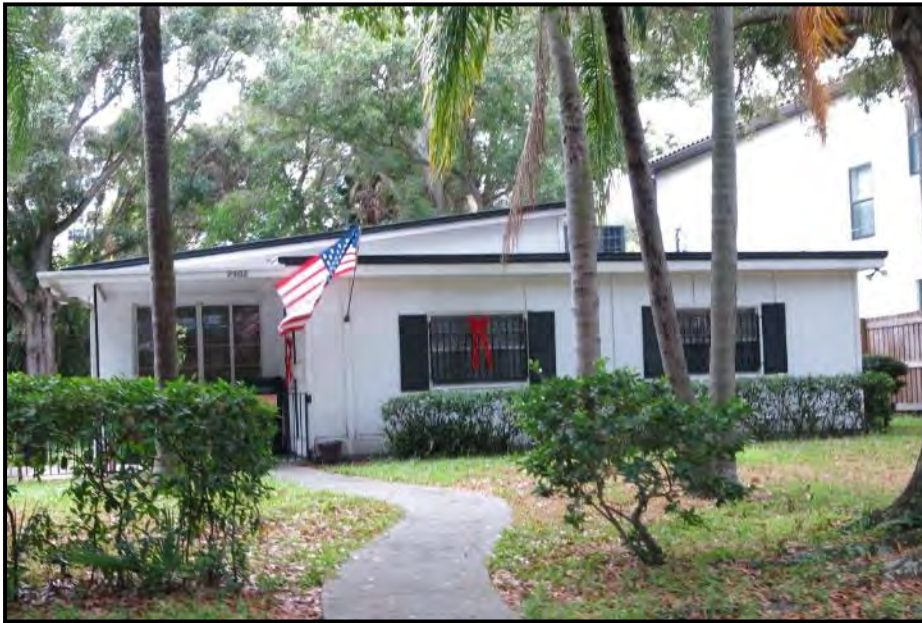
Mid-Century Modern: Three historic resources within the APE are of the Mid-Century Modern style (8HI14746, 8HI14779, 8HI14786) (**Photo 5.28**) and have construction dates that range from 1953 through 1961 (see **Table 5.3**). Two of the resources are single-family residential buildings and two are multi-family residences. Mid-Century Modern buildings are inspired by the International style and feature flat roofs, multiple windows, and minimal ornamentation (McAlester 2013). Within the APE, the buildings typically feature slab foundations, gable, shed, or flat roofs covered with built-up materials, exterior masonry cladding, and fixed and awning type windows. Exterior ornamentation is minimal. Most of these buildings display alterations or additions, such as replacement siding and windows and living-space additions.

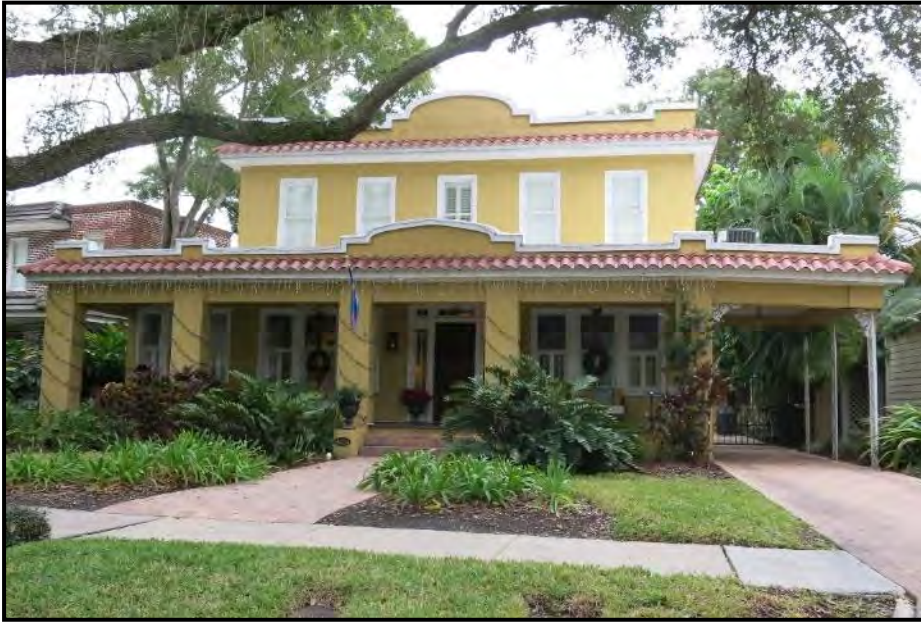
Mission: Three historic resources within the APE are of the Mission style (8HI07210, 8HI07209, 8HI02015) (**Photo 5.29**). They are residential buildings constructed ca. 1924 and ca. 1926 (see **Table 5.3**). The Mission style was inspired by Spanish architecture and was particularly popular in Florida in the 1920s. The style typically features mission-shaped dormers or roof parapets, red tile roof coverings, widely overhanging eaves, porch roofs supported by large, square piers with arches, and smooth stucco cladding (McAlester 2013). Within the APE, the residences are covered with stucco or brick and have continuous foundations and flat roofs clad with built-up materials. Exterior ornamentation features parapet roofs. All of the residences exhibit alterations such as replacement windows or additions.

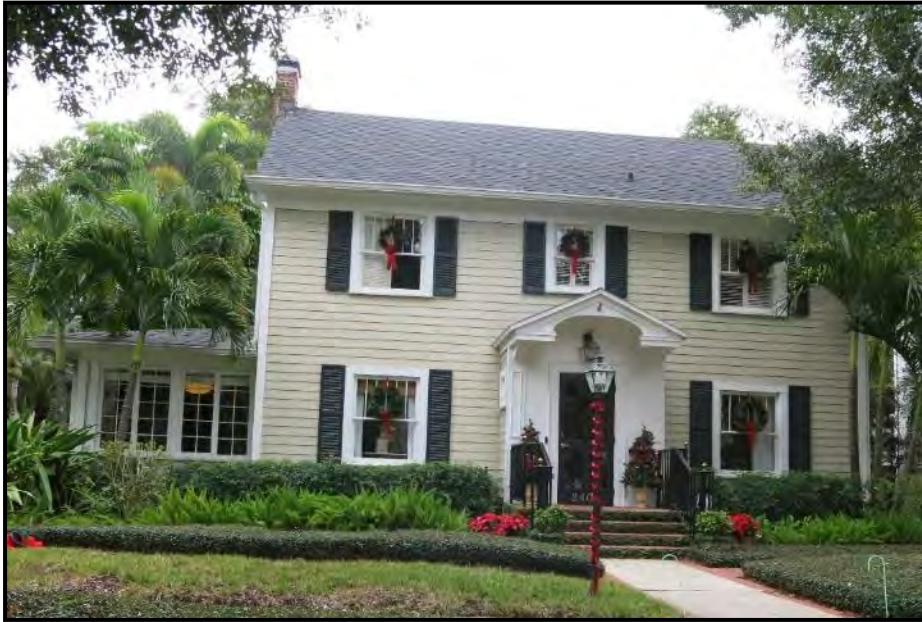
Photo 5.30. 2406 W Prospect Rd (8HI07211), looking southeast.

Colonial Revival: Five historic resource within the APE is of the Colonial Revival style (8HI01285, 8HI07211, 8HI07212, 8HI07213, 8HI07218) (**Photo 5.30**) and were constructed between ca. 1924 and ca. 1928 (see **Table 5.3**). The Colonial Revival style was formed in the 1880s when there was a renewed interest in Dutch and Colonial American architecture. The style continues to be built today, and examples often include gable roofs, paired and symmetrically placed windows, and front doors accentuated by pediments, fanlights and sidelights, or entry porches (McAlester 2013). Within the APE, this style building typically has a continuous brick foundation and is two-stories with a one-story side wing. The gable and hip roofs are clad with composition shingles, and the walls are covered with wood or vinyl siding. Exterior ornamentation includes fixed shutters, window trim, and accentuated front doors. Alterations include replacement siding, windows, and roofing.

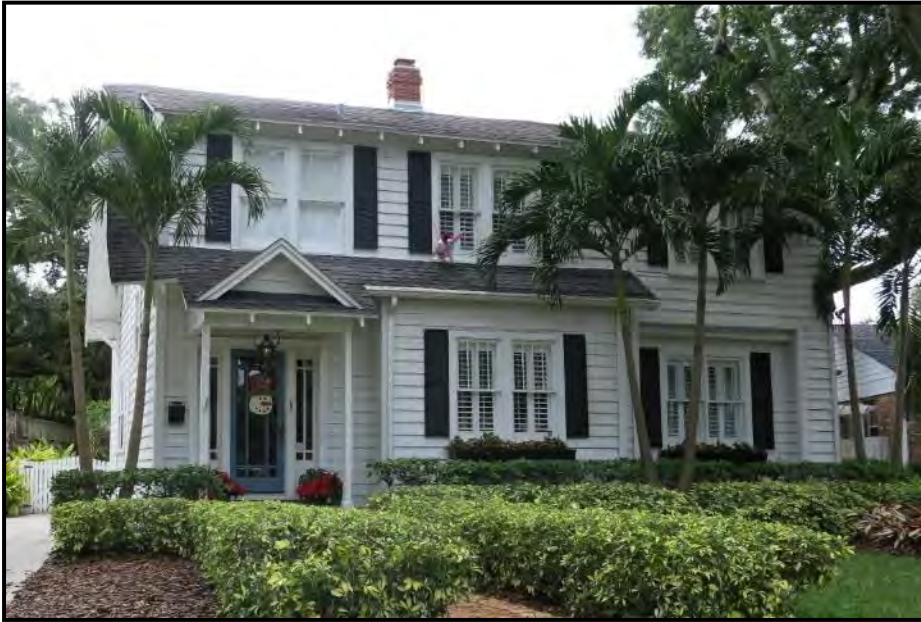
Photo 5.31. 2420 W Prospect Rd (8HI07220), looking southeast.

Dutch Colonial Revival: One historic resource (8HI07220) within the APE is of the Dutch Colonial Revival style (**Photo 5.31**). This residence was built ca. 1927 (see **Table 5.3**). The Dutch Colonial Revival subtype of Colonial Revival was formed in the 1880s when there was a renewed interest in Dutch and Colonial American architecture. The style continues to be built today, and examples often include Colonial Revival features such as paired and symmetrically placed windows, and front doors accentuated by pediments, fanlights and sidelights, or entry porches; however, this subtype of Colonial Revival features a gambrel roof and commonly utilizes dormer windows or continuous shed dormers with several windows (McAlester 2013). This building has a continuous concrete foundation. The gambrel roof with shed dormer and shed roof extension are clad with composition shingles, and the walls are covered with clapboard siding. Exterior ornamentation includes an accentuated front door, overhanging eaves with exposed rafter tails, shutters, corner boards, wooden brackets, and wood trim around the windows and doors. Alterations include replacement roofing; an addition was constructed on the east elevation.

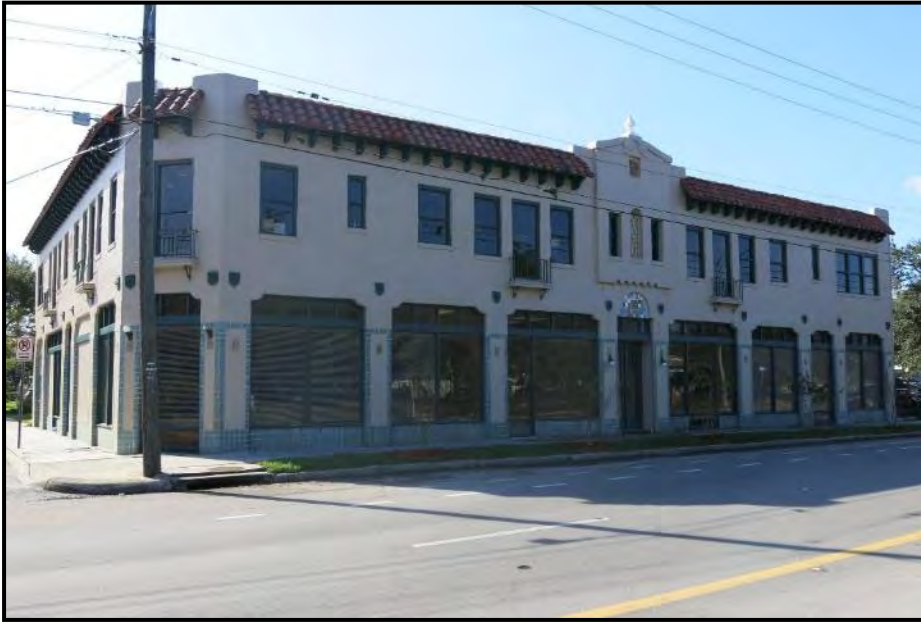
Photo 5.32. 1200 Platt St (8HI01318), looking southwest.

Mediterranean Revival: Two historic resources (8HI01318, 8HI02117) within the APE are of the Mediterranean Revival style (**Photo 5.32**). The mixed-use commercial-residential buildings were built ca. 1925 (see **Table 5.3**). The Mediterranean Revival style is most common in regions where Spanish Colonial building occurred, such as Florida. During the 1920s, the style was commonly utilized for new development and was made popular by developers such as Addison Mizner. The style continues to be built today, and examples often include flat roofs with decorative parapets and red tile roofing, arched or decorative openings, ornate details such as inlaid tile or carvings, and iron railing balconies (McAlester 2013). Within the APE, these buildings have a concrete slab foundation, flat roofs with parapets and overhanging Mission and Spanish tile pent roof surrounds, and the walls are covered with stucco. Exterior ornamentation includes decorative parapets, balconies or balconettes, and inlaid tile. Alterations include replacement roofing, windows, siding, and altered storefronts.

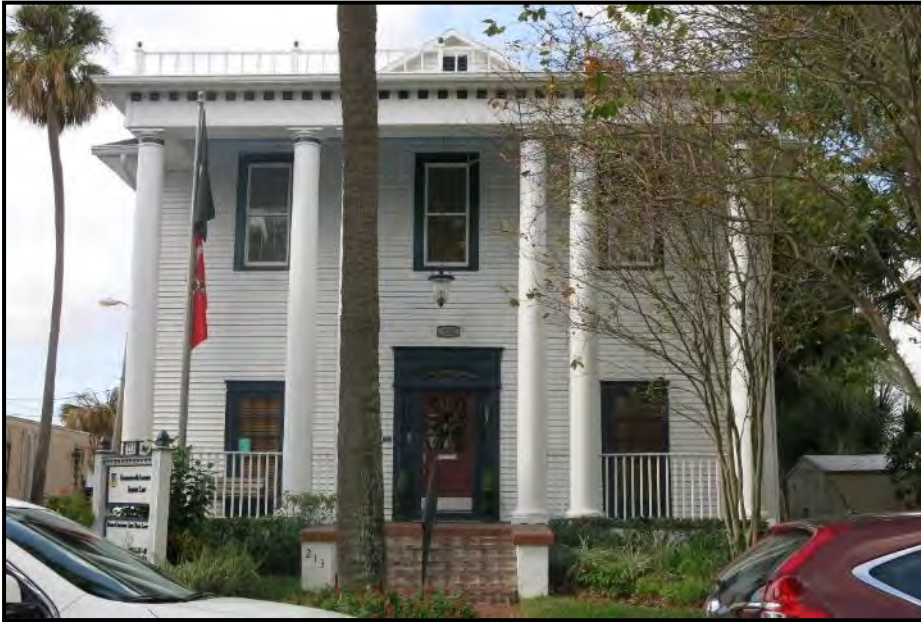
Photo 5.33. 213 S Brevard Ave (8HI14822), looking west.

Neoclassical Revival: One historic resource (8HI14822) within the APE is of the Neoclassical Revival style (**Photo 5.33**). This residence was built ca. 1907 and is now utilized as an office building (see **Table 5.3**). The Neoclassical Revival style was developed and became a dominant style for domestic architecture during the early to mid-twentieth century. The style was inspired by the renewed interest in classical architecture at the 1893 World's Columbian Exposition and incorporates features of the Georgian, Federal, Early Classical Revival, and Greek Revival styles. Examples often include a full-height porch with a roof supported by classical columns, a symmetrically balanced front elevation with a centered entrance and decorative surround, and roofline balustrades (McAlester 2013). This building has a continuous and pier brick foundation. The gable on hip roof and various extensions are clad with composition shingles, and the walls are covered with vinyl siding. Exterior ornamentation includes unfluted columns, a roofline balustrade, decorative trim around the windows and doors, a plain entablature with modillions, and gable vents. Alterations include replacement siding, windows, and roofing.
