SELMON
EXPRESSWAY

South Selmon PD&E Study

**Cultural Resource
Assessment Survey
Report**

June 2021

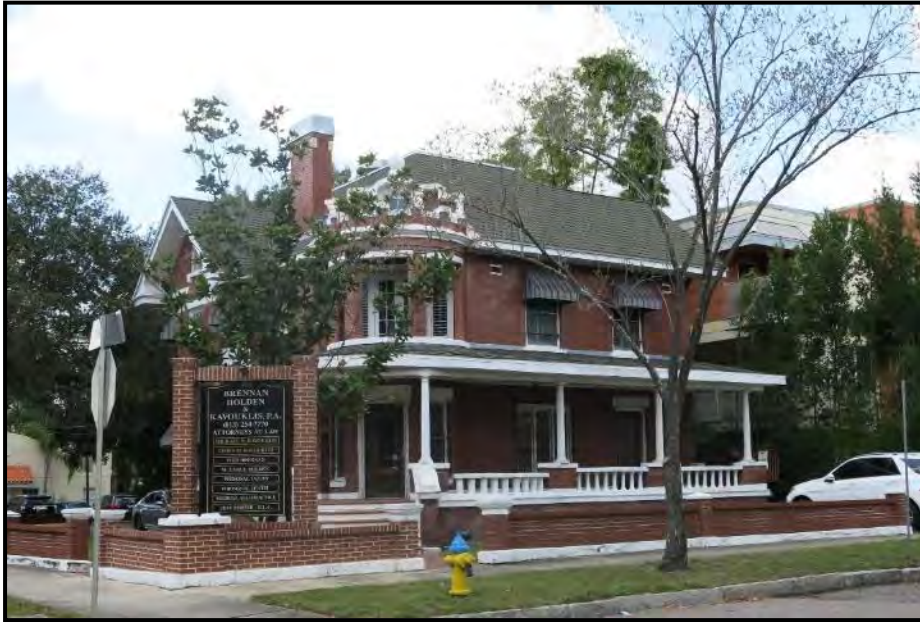
Queen Anne Revival: One historic resource (8HI01439) within the APE is of the Queen Anne Revival style (**Photo 5.34**). This residence was built ca. 1914 and is now used as an office building (see **Table 5.3**). The Queen Anne Revival style was formed in the late nineteenth century and grew in public popularity by 1880 through the dissemination of pattern books and architecture magazines. Examples often include steeply pitched roofs of irregular shape, asymmetrical façade with a partial or full-width porch, details such as bay windows to avoid a smooth-walled appearance, and features such as spindlework of classical columns (McAlester 2013). This building has a continuous brick foundation. The cross-gabled and hip roofs are clad with composition shingles and the walls are brick. Exterior ornamentation includes a crenelated parapet, concrete windowsills and lintels, dentils, columns on brick piers with concrete caps and railing, and a stepped parapet with finials. Alterations include replacement roofing, windows, and columns, as well as the installation of security bars and awnings.

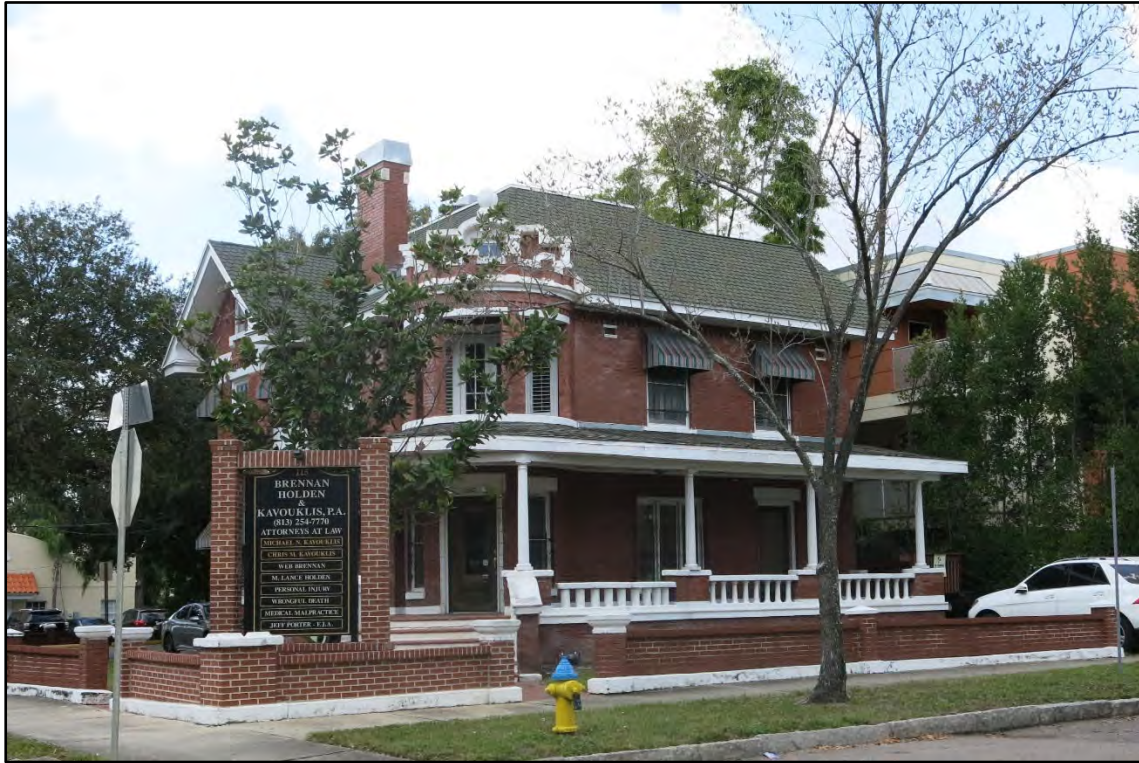
PHOTOGRAPHS

Condition (overall resource condition): [] excellent [] good [x] fair [] deteriorated [] ruinous

A 2.5 story Queen Anne style building w/ infilled foundational arches and wing walls w/ curved concrete caps along porch steps.

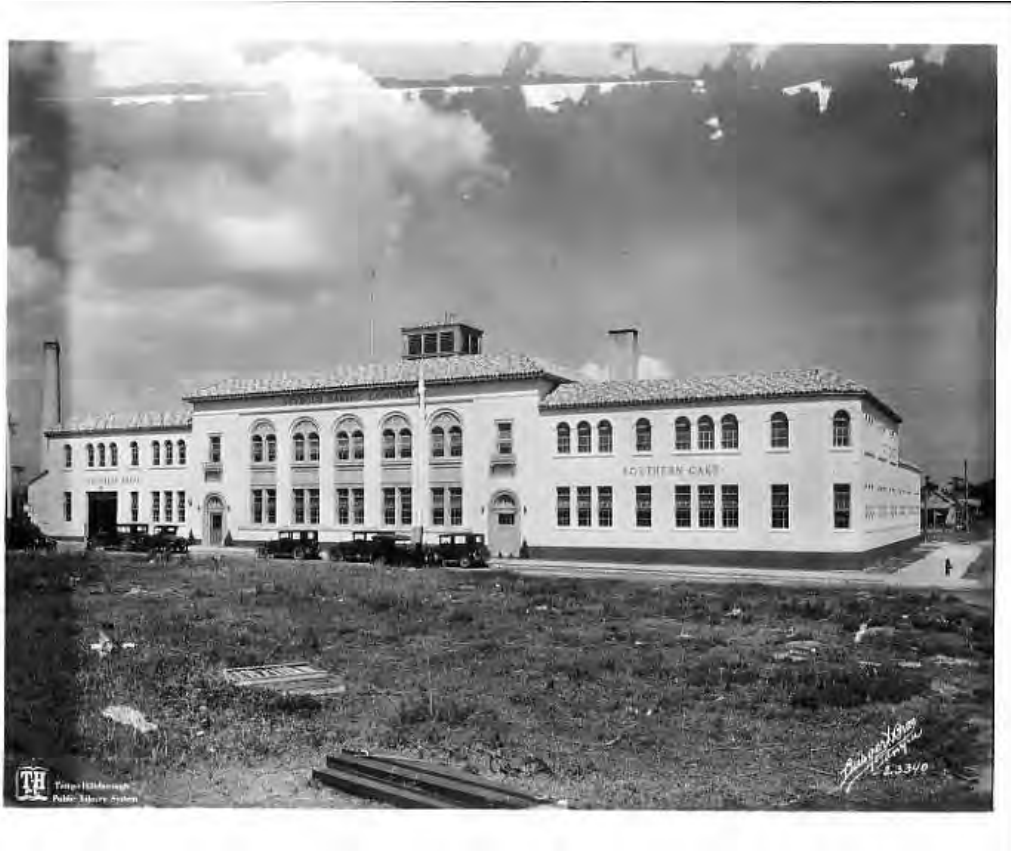
Photo 1. 1927 historic photograph depicting the ca. 1926 Seybold Bakery, facing northeast (HCPLC n.d.)

Narrative Description: The Seybold Bakery at 1501 W Horatio Street (formerly 420 S Dakota Avenue) in Tampa, Florida is a circa (ca.) 1926 Mediterranean Revival style factory located in Section 23 of Townships 29 South, Range 18 East (USGS Tampa, 1956). The property fronts S Dakota Avenue along its western frontage, W Horatio Street along its southern boundary, S Oregon Avenue along its eastern boundary, and the Lee Roy Selmon Expressway and W Azele Street along its northern boundary. Four structures are currently present on the parcel, the main ca. 1926 Mediterranean Revival style factory (8HI01759) and three ca. 2008 apartment carports. All are free standing and do not engage one another. A ca. 2005 condominium and townhouses are located immediately adjacent to the east elevation of the building and associated parking lot; however, the buildings are located on a separate parcel. The Seybold Bakery factory was constructed in ca. 1926 by the Seybold Baking Company, the owners and bakers of the Southern Breads and Southern Cakes brands (**Photo 1**). Producing the same brands, the Columbia Baking Company took over the operation during the mid-1940s followed by Southern Bakeries Company during the mid-1950s. In 1971, ITT Continental Baking Company began operation and the factory was utilized to produce Wonder Bread products until 2003 (B.C. Manion 2003, City of Tampa 2018). The transition into a residential development began in 2004 and the building received local historic designation in 2005 (Poltilove 2004, City of Tampa 2018). The Seybold Bakery is listed as a contributing resource to the National Register of Historic Places (NRHP)-listed Hyde Park Historic District (FMSF 8HI01050).

Explanation of Evaluation: Overall, the Mediterranean Revival style factory located at 1501 W Horatio Street is not a typical style utilized for industrial architecture throughout the area. Due in part to alterations completed to return the building to a state more closely resembling the original historic appearance, the building maintains most of its character-defining architectural and decorative features. The ca. 1926 Seybold Bakery (8HI01759) was designated a Local Historic Landmark by the City of Tampa in 2005 following the transformation from a factory to a residential building (City of Tampa 2018). No significant alterations have been completed since this designation. As a result, 8HI01759 appears eligible for listing in the NRHP individually under Criterion C in the area of Architecture and the building appears to retain integrity as a contributing resource to the NRHP-listed Hyde Park Historic District (8HI01050).

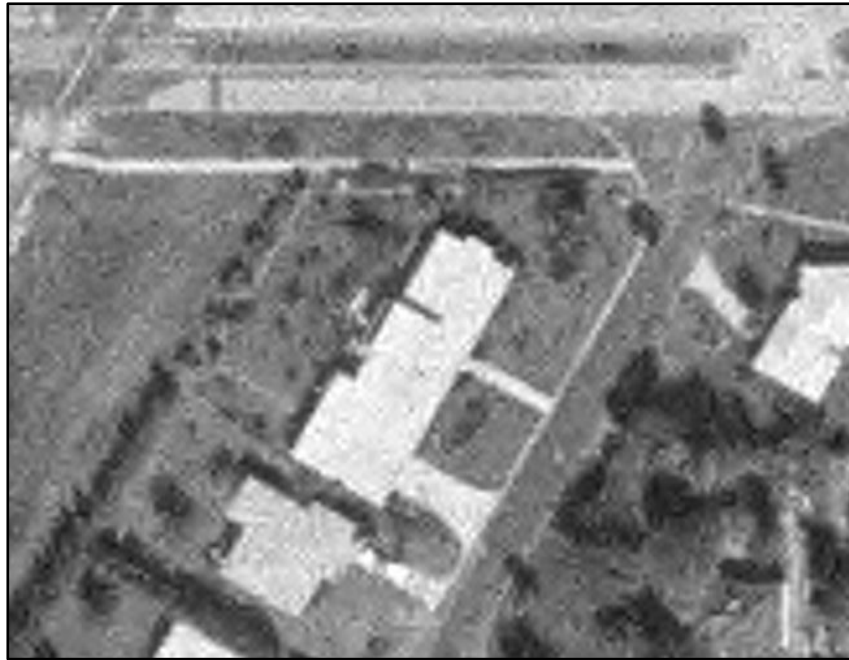
Photo 3. 1965 historic aerial photograph depicting 3501 S Drexel Avenue (FDOT 1965).

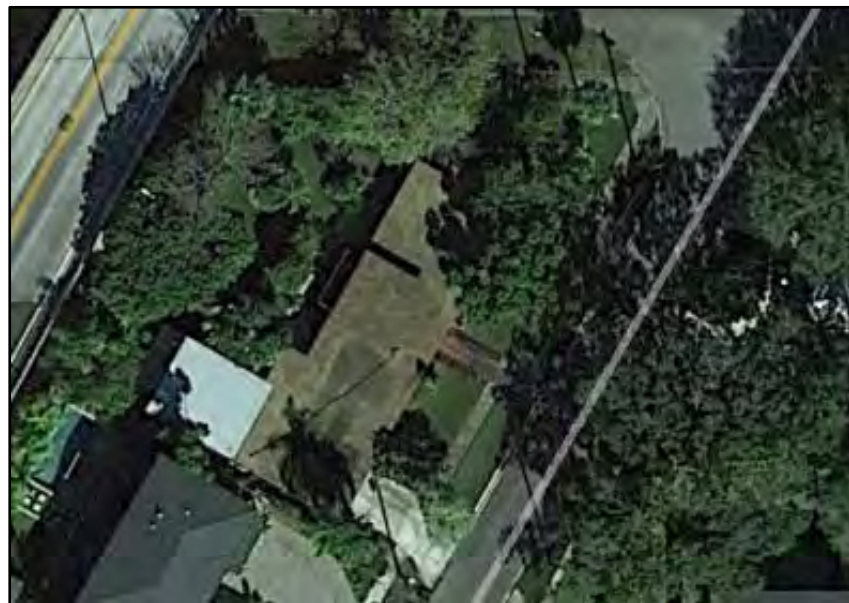
Photo 4. 2019 aerial photograph depicting the flat roof addition on the southwest elevation (Google Earth 2019).

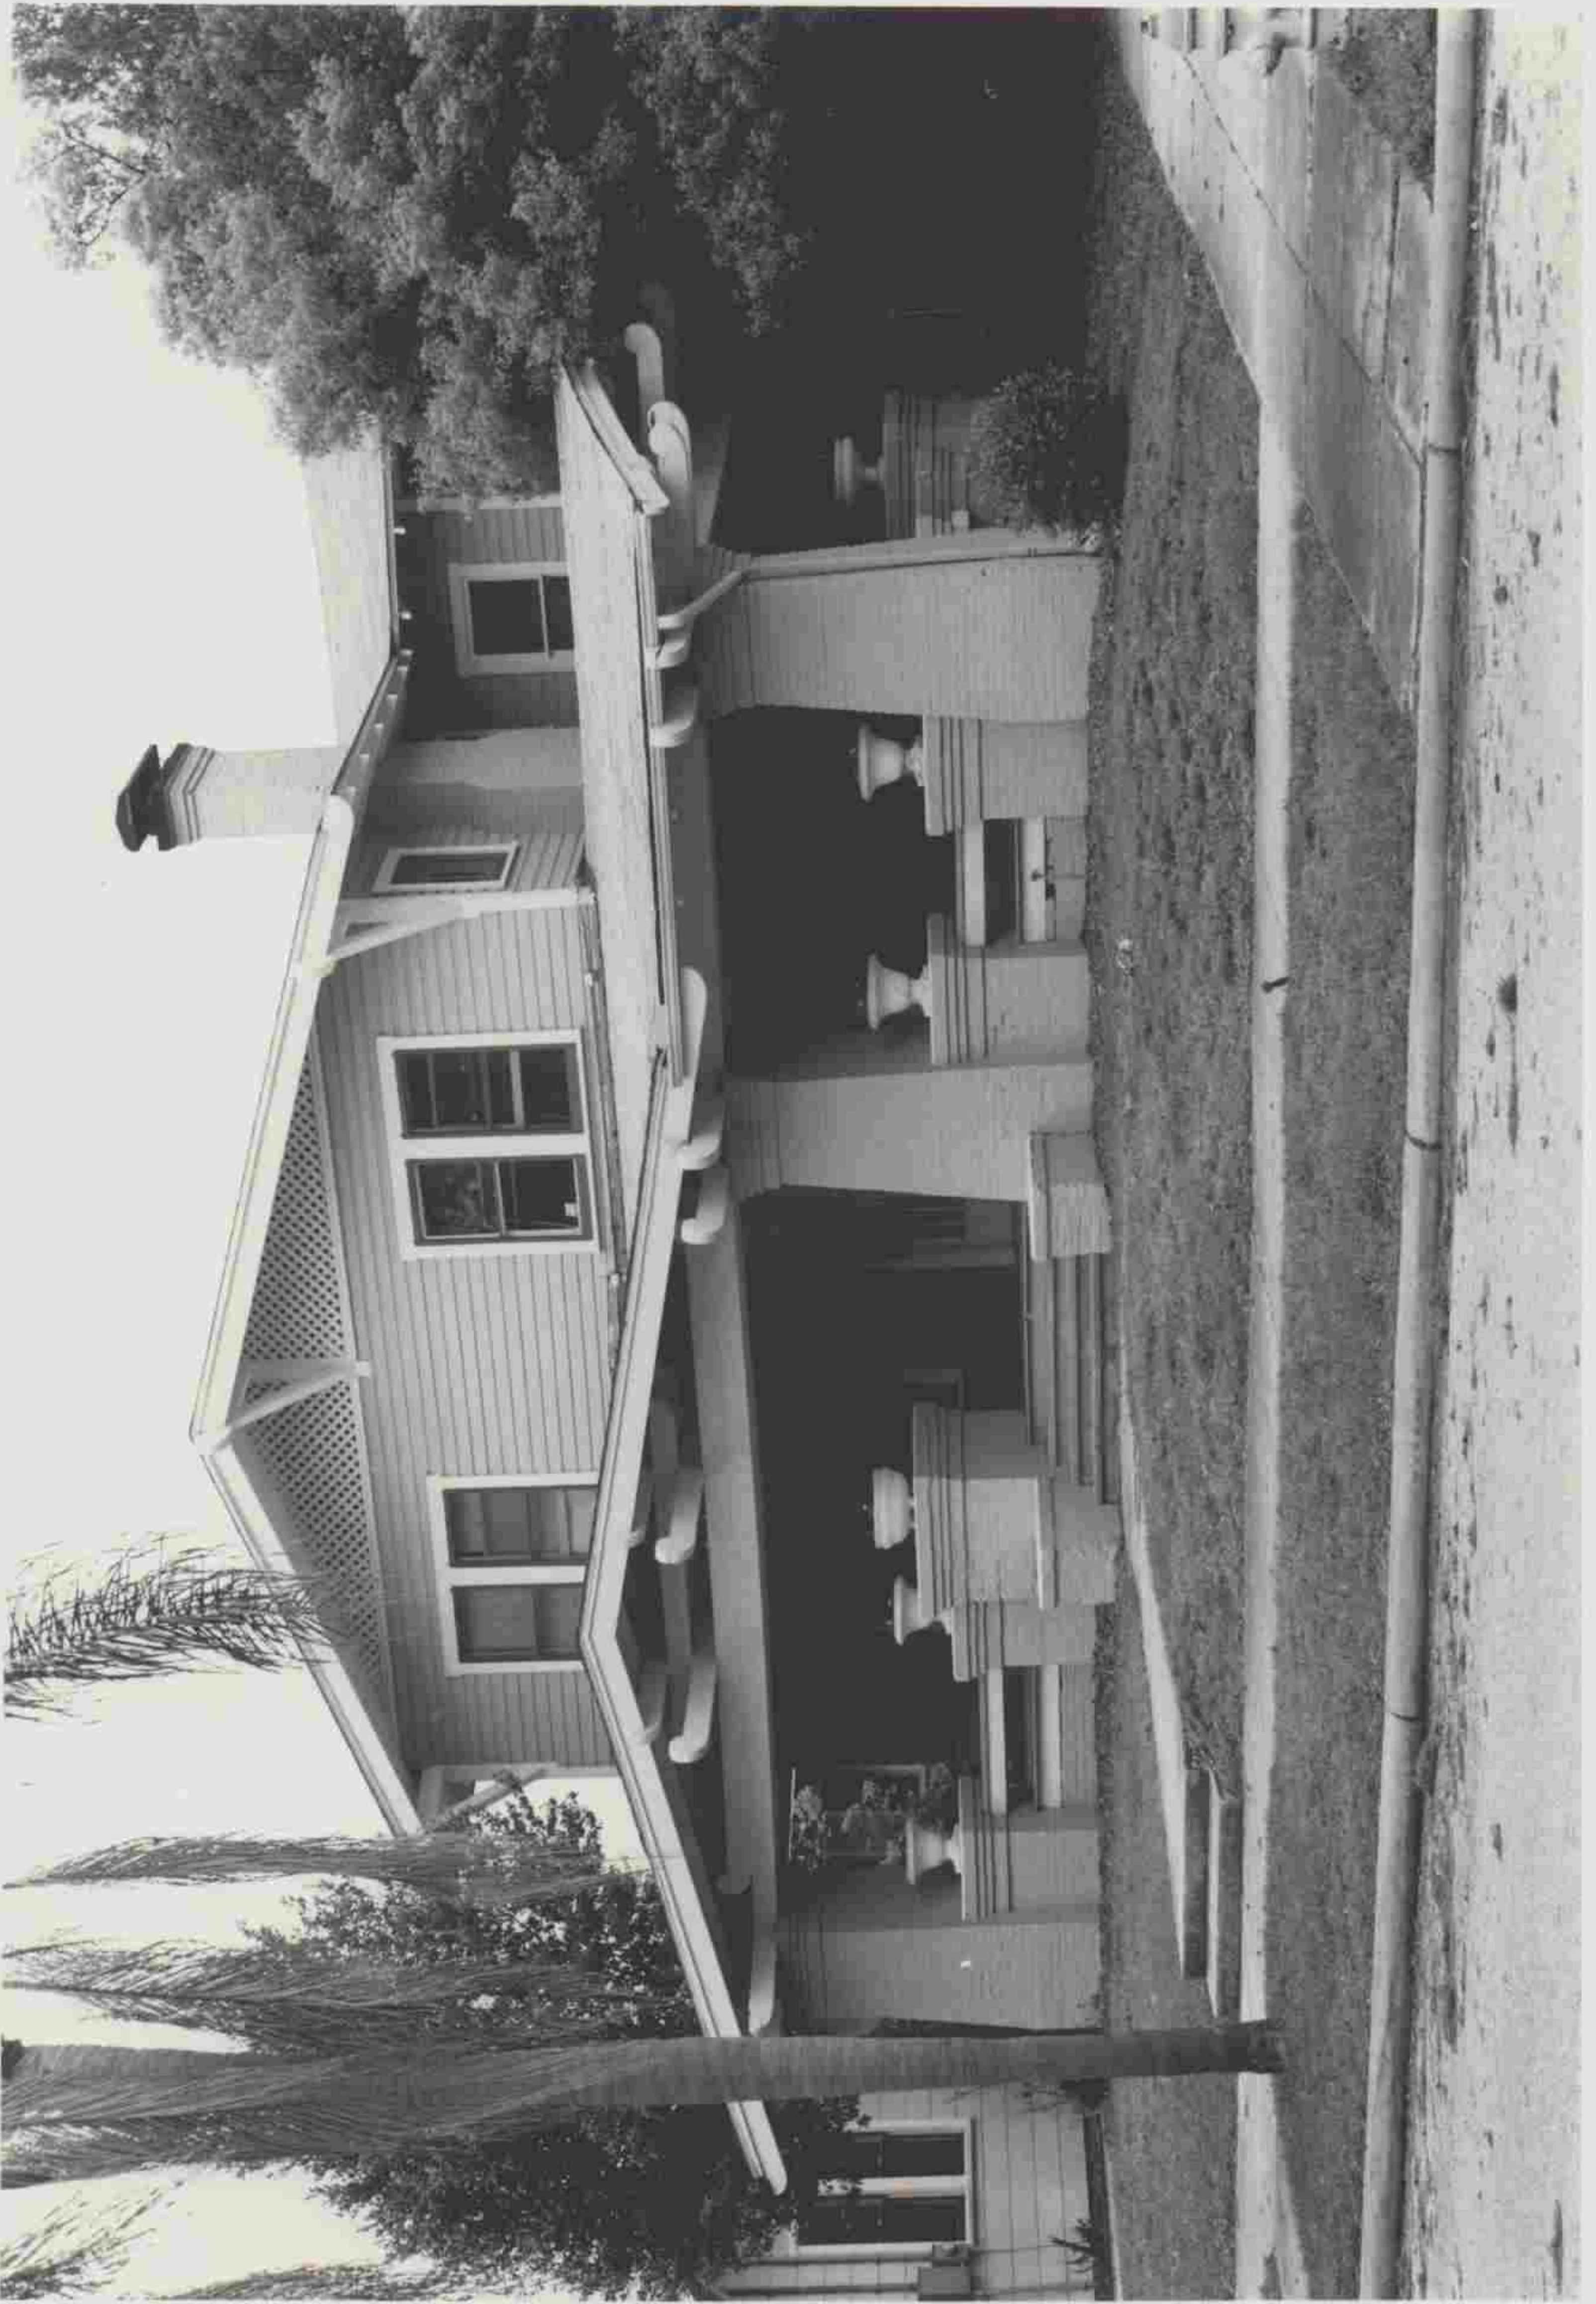
1. Hyde Park Historic District
2. 902 Delaware Ave. Tampa
(Hillsborough County), FL
3. Carl Shiver
4. 1984
5. Historic Tampa/Hillsborough County
Preservation Board
6. West Facade
7. Photo 35 of 94

Houses of this type in the district are generally referred to as "Tudor" or "Jacobean." The variations of the type cover a wide range so that it is necessary to point out just a few characteristics shared by most of them. The English Romantic Revival house seeks to emulate a "medieval" appearance. Typical features are a steeply pitched roof, a prominent chimney, small windows (casement or vertical sash), the prominent use of half-timbering, and rough brickwork or fieldstone (photo 35).

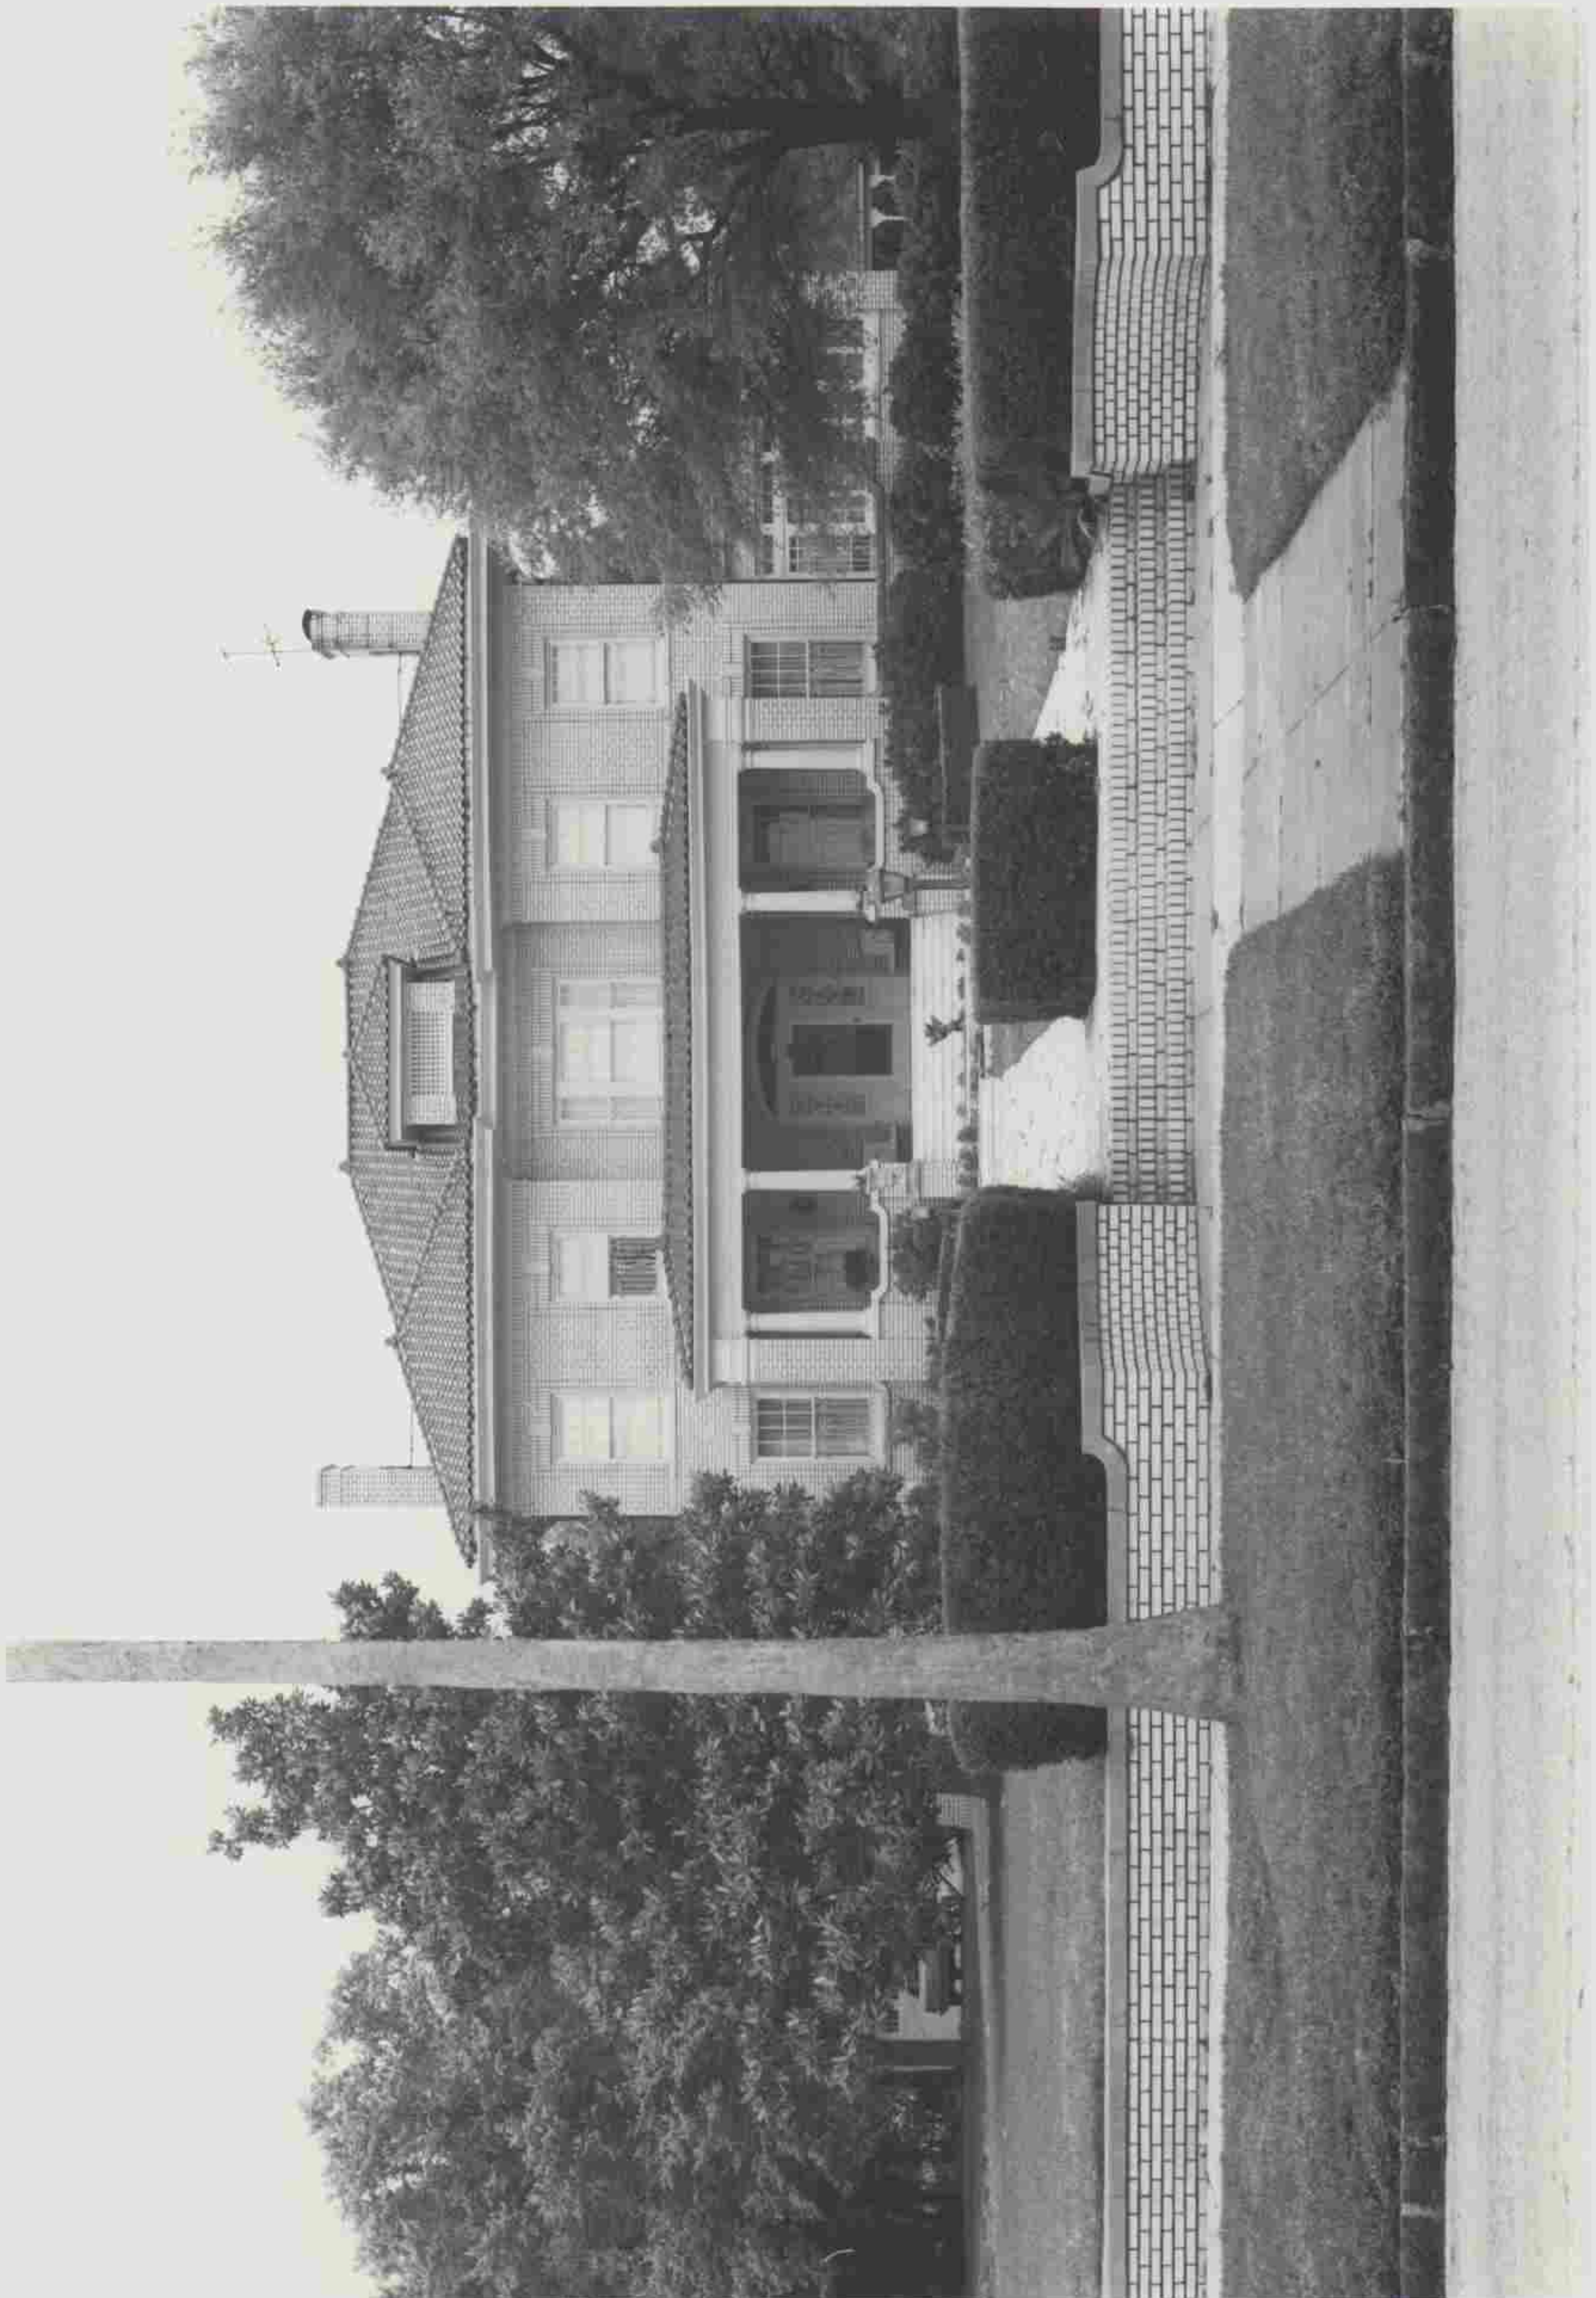
1. Hyde Park Historic District
2. Bayshore Blvd. Tampa
(Hillsborough County), FL
3. Carl Shiver
4. 1984
5. Historic Tampa/Hillsborough County
Preservation Board
6. Looking north from Nance St.
7. Photo 39 of 94

The larger "styled" houses in Hyde Park are, for the most part, found in the Morrison Grove or "Suburb Beautiful" section of Hyde Park, and one of the most desirable locations for a house in that area was along Bayshore Boulevard. Swann and Holtsinger influenced the development of the Bayshore when they began filling in the mud flats along the water's edge in 1907.³² In 1912 the city of Tampa condemned a strip of land along the water's edge between Swann and Howard for a thoroughfare.³³ In 1914 "Bayshore Boulevard" was paved and a seawall constructed. The first sidewalk and balustrade was completed about ten years later.³⁴ During the 1930s the roadway was widened to four lanes and the present balustrade, with its "classical" urn balusters was constructed (photo 39).³⁵ (See Addendum for more information on Bayshore Boulevard.)

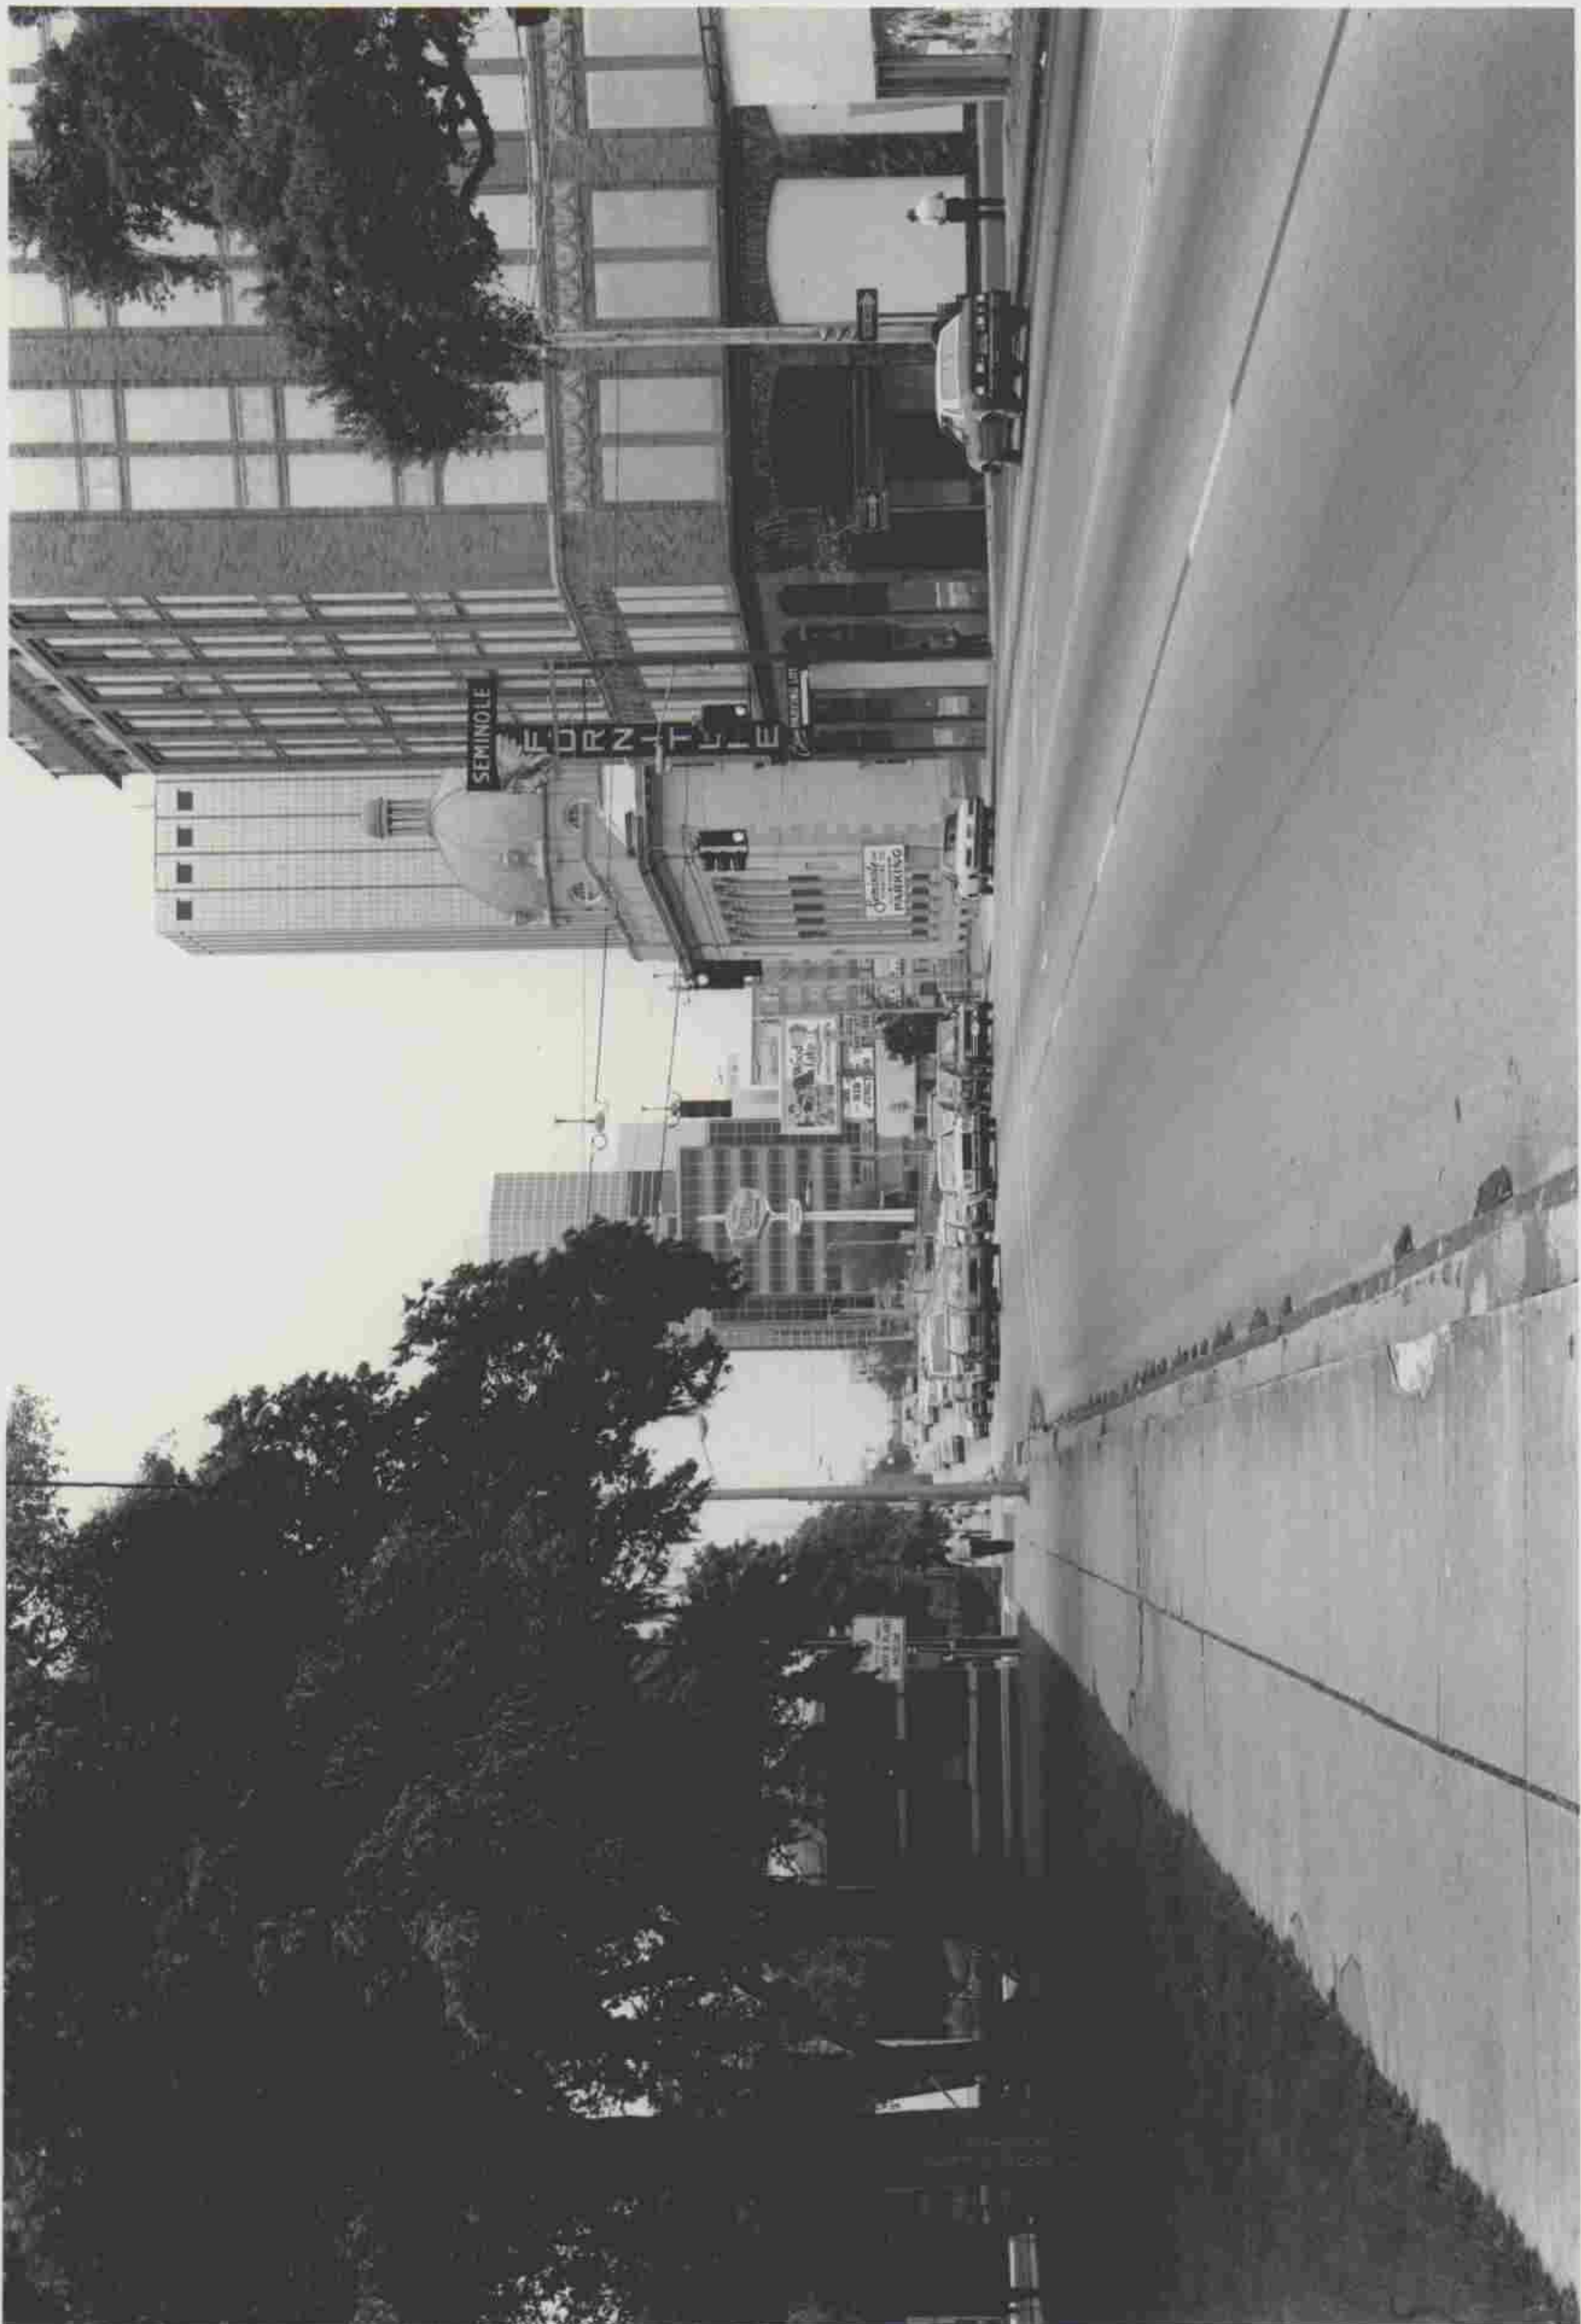
1. Hyde Park Historic District
2. Snow Park, Tampa
(Hillsborough County), FL
3. Carl Shiver
4. 1984
5. Historic Tampa/Hillsborough County
Preservation Board
6. Looking S.E. at Kennedy & Grand Central
7. Photo 61 of 94

Snow Park is a small area of land at the intersection of Kennedy Boulevard, Grand Central Avenue, and Magnolia Avenue (photo 61). Originally nothing more than a traffic island, it was dedicated to Henry E. Snow in 1920.⁴⁰ The city of Tampa decided to improve the park in 1925 by providing it with a fountain enclosed by a small pavilion. The work was completed in 1926 shortly after Snow died, but less than a decade later the pavilion was destroyed when struck by an automobile.⁴¹ The site remained neglected until 1984 when the city began work to enlarge the park, plant shade trees, and erect a new pavilion. The work is expected to be finished in 1984.

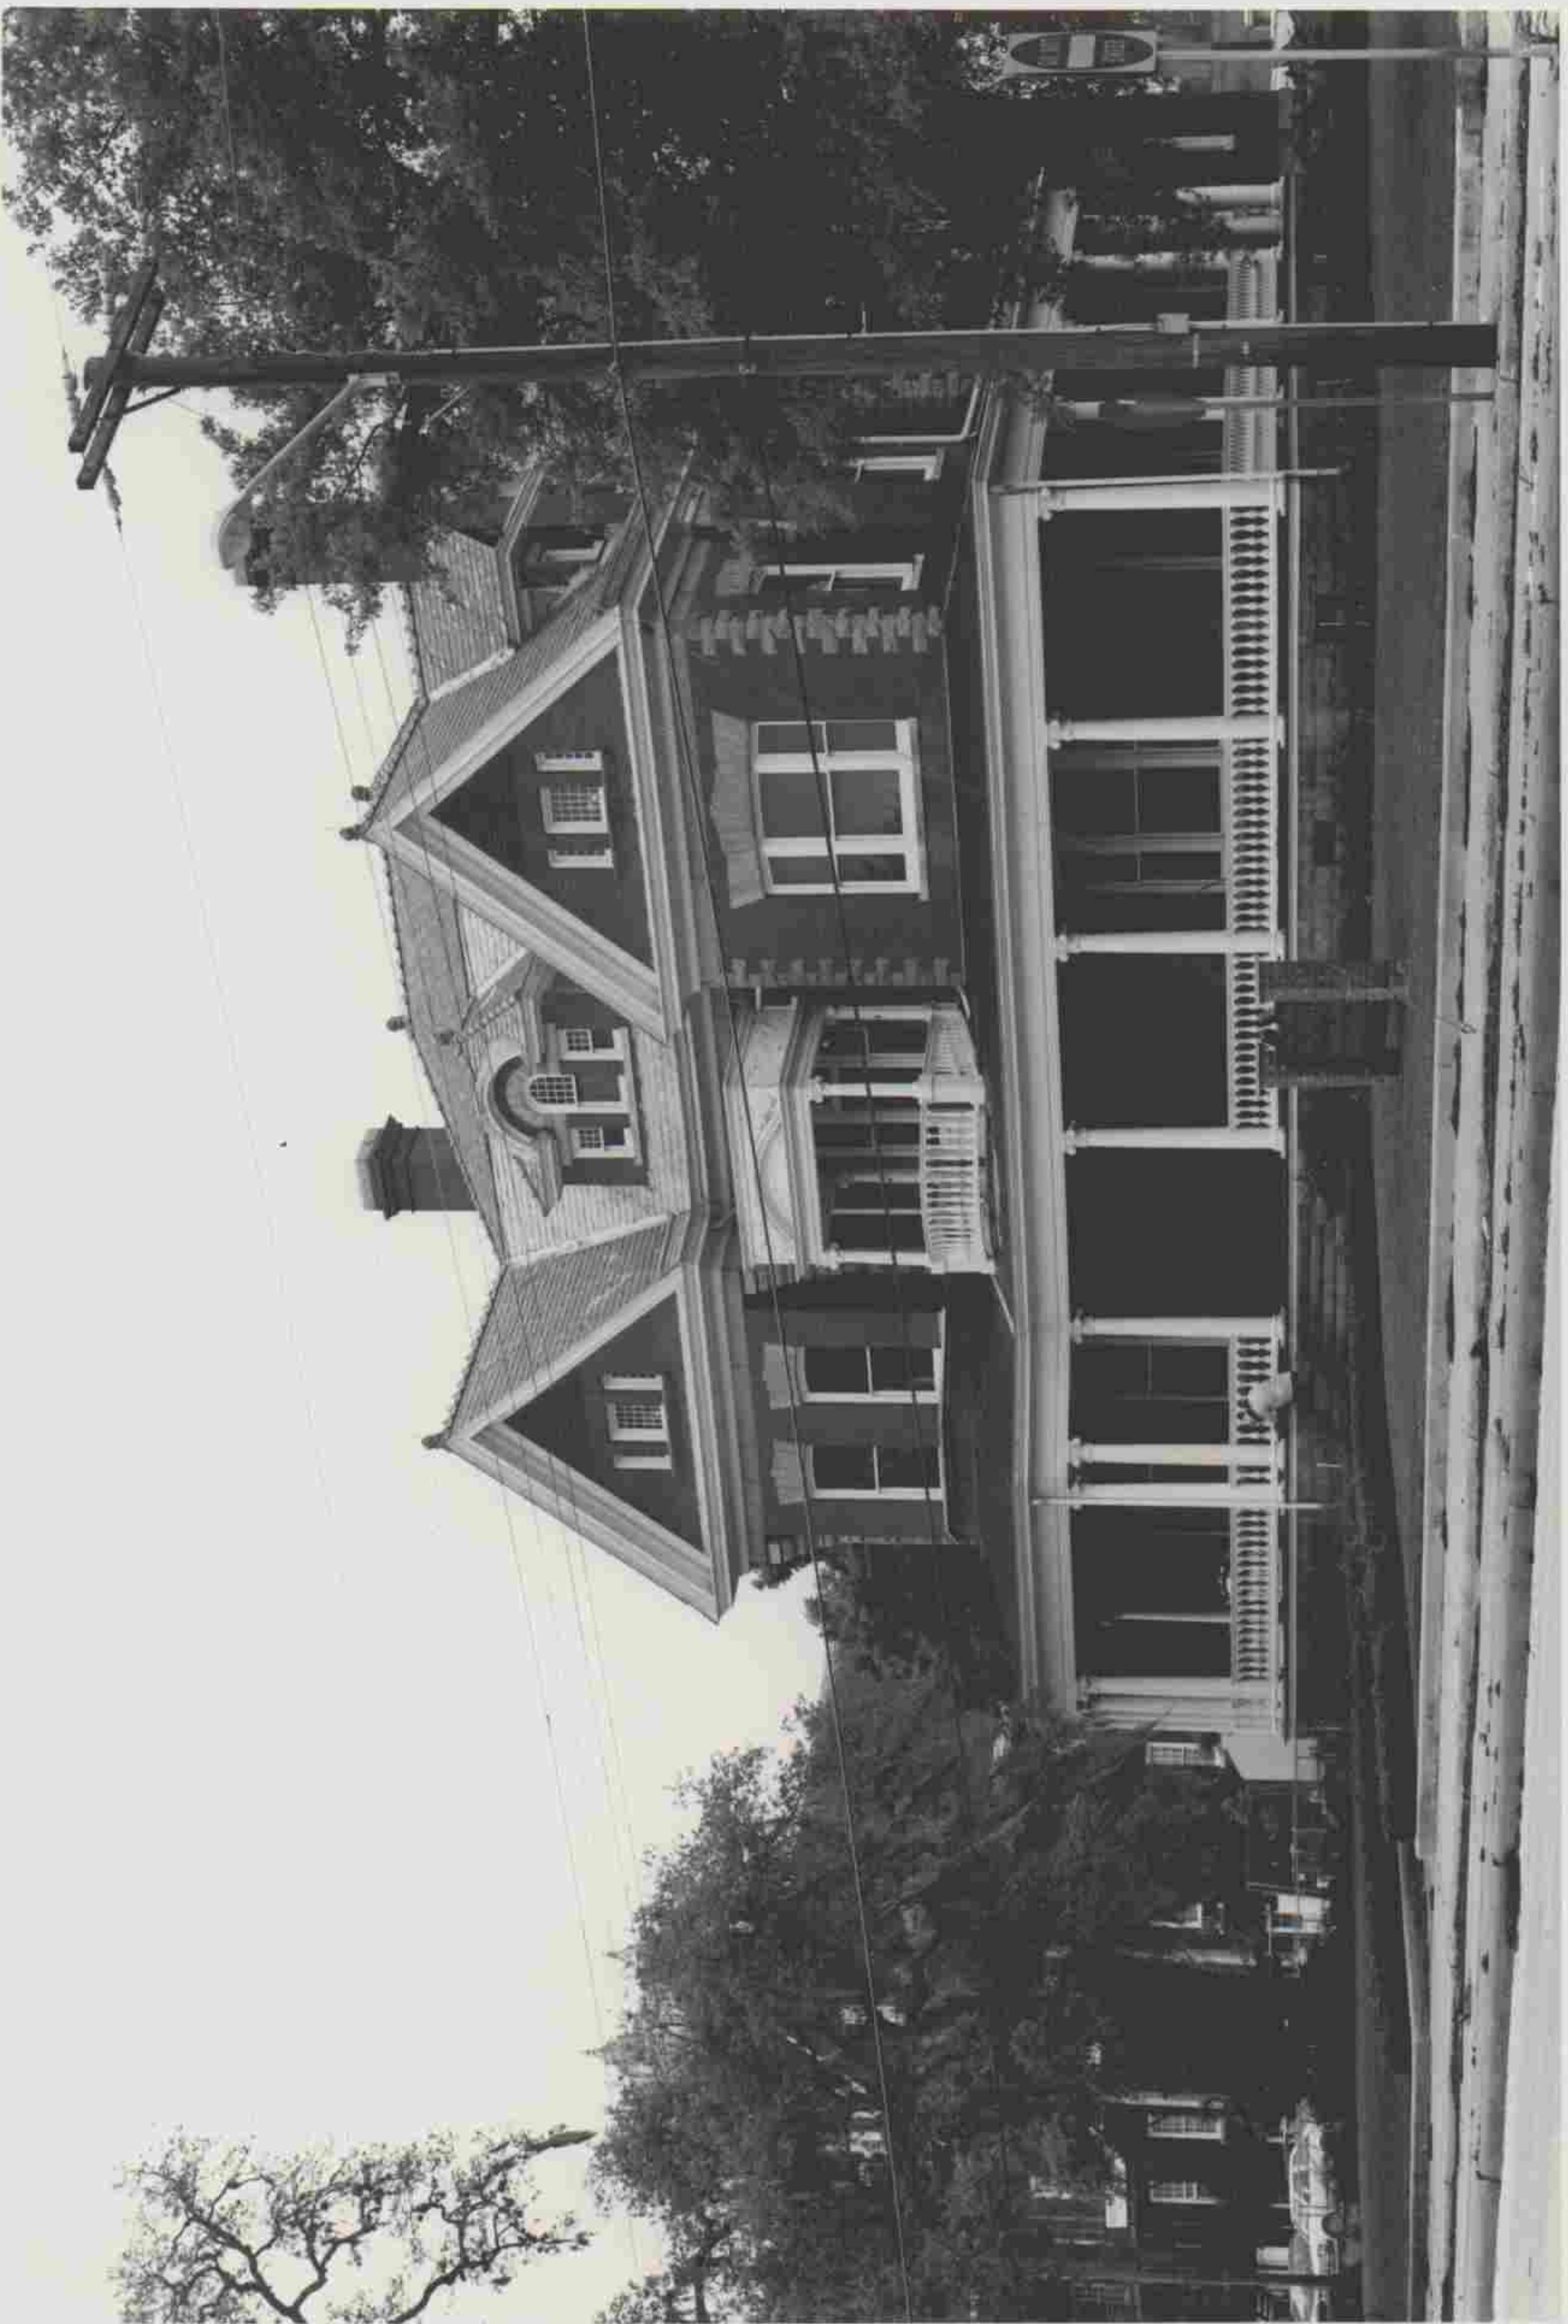
1. Hyde Park Historic District
2. Hutchinson House, 304 Plant Ave.
Tampa (Hillsborough County), FL
3. Carl Shiver
4. 1984
5. Historic Tampa/Hillsborough County
Preservation Board
6. West Facade
7. Photo 69 of 94

The Second Empire style is represented by a single example in Hyde Park: the Hutchinson House (ca. 1908), 304 Plant Avenue. The most distinctive feature of houses of this type is the high mansard roof over the third story. Also typical are the Hutchinson House's arched wall dormer windows, the projecting wall pavilions, and its sense of massiveness (photo 69).
